Underground Construction Technology

Why Inspect Manholes?

Visual Manhole Inspection

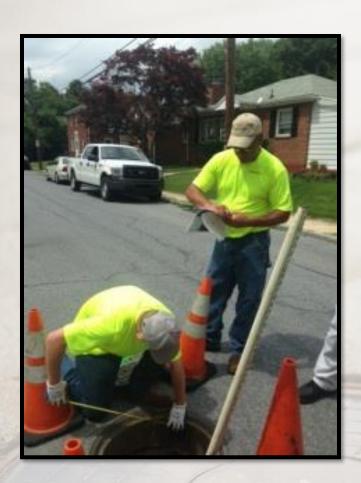
- No special equipment required
- Limited visual observations from ground level
- Possible confined space entry if required
- No video documentation
- Possible photo documentation
- Observations noted on paper forms or database

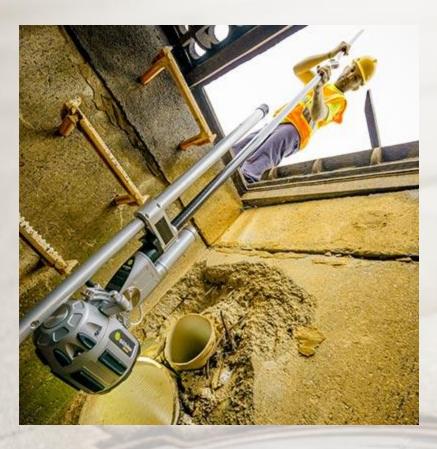
Handheld Pole Camera

- Battery operated
- Portable, one man operation
- Inspection depth of 25 feet
- Unstable handheld panning/rotation of camera in manhole
- Better suit for screening connecting pipelines
- Inspect approximately 10 manholes per day depending on manhole depth
- Ideal for offroad, difficult to access manholes

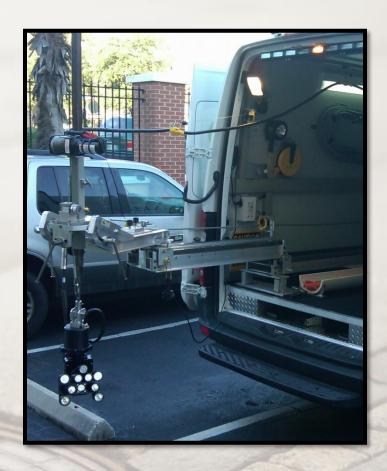
Truck Mounted Motorized Pole Camera

- 30 ft telescopic mast
- Motorized pan/tilt control of inspection video
- Remote controlled from truck office
- Ideal for onroad inspections and connecting pipelines
- No measurements

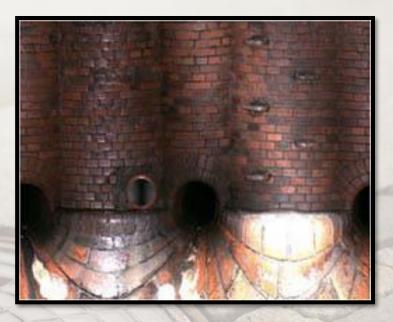
"Side Scanning" Photographic Camera

- Point cloud has limited density
- Depth of manhole inspected relies on reel cable
- Point cloud data and imagery are separate devices
- Data is merged together using proprietary software
- System must be stable and vertical
- Zero calibration necessary (possible human error)
- Limited to point-to-point measurement

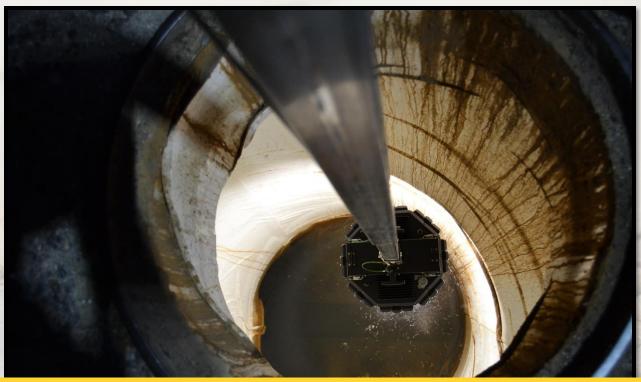
Technology Timeline

Pre-1980 – Visual Inspection

1985 to 2008 – Video Camera / Pole Camera

2009 to 2016 – 2D Side Scanning with Measurement

2018 - 3D Scanning / Modeling

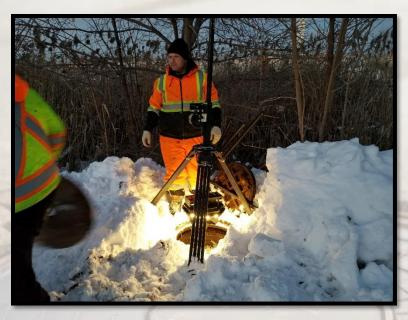
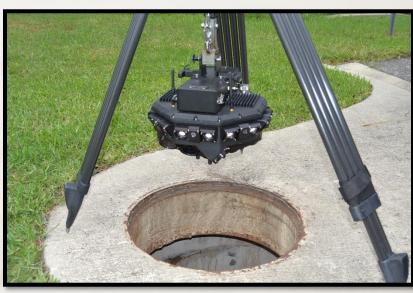
3D Wireless Scanning

- Portable Battery Operated
- Wireless, not tethered to power or data
- Tablet control
- High production
- Minimal site time 10 ft/min

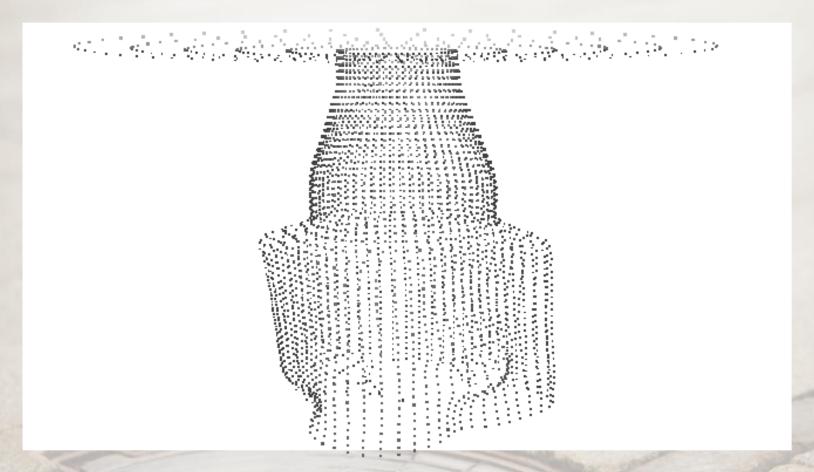
Side Scanning Point Cloud

Sparse and Single Color – Made for point to point measurement

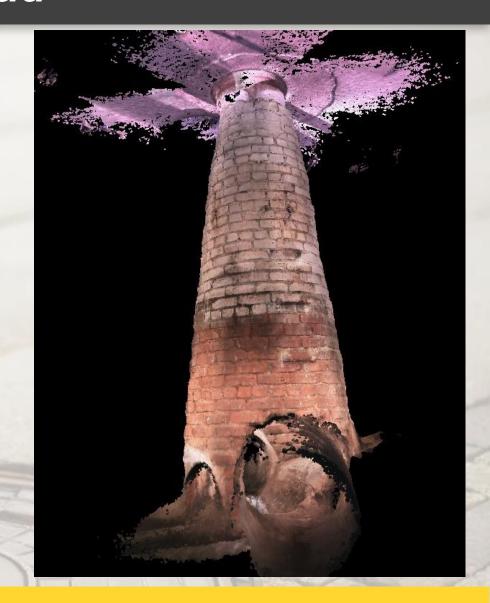
3D Scanner Point Cloud

Color and **Solid** Density
Point Cloud

Increased Density Equates
To Increased Accuracy of
Measurement – up to 1 mm

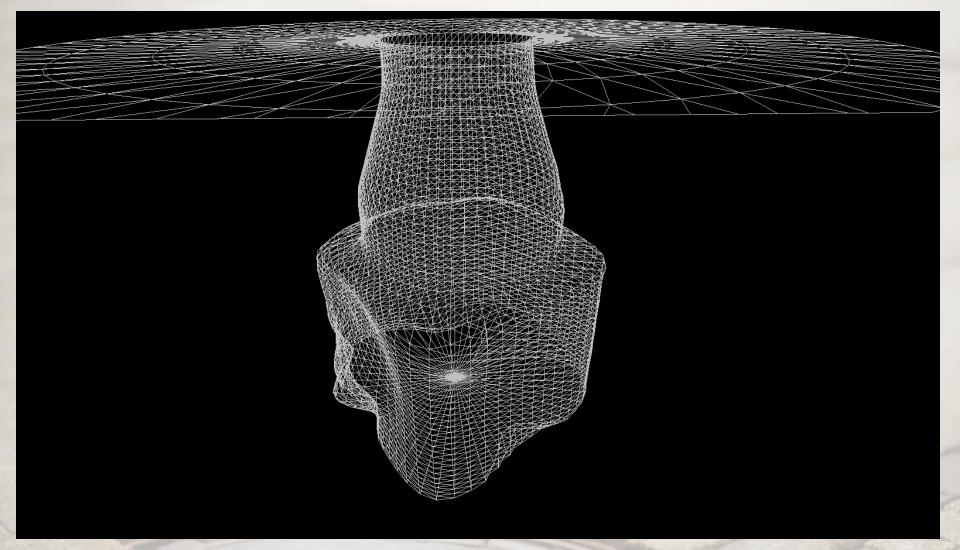
Solid Density Point Clouds Create Measurable Meshes Instead of point to point measurement

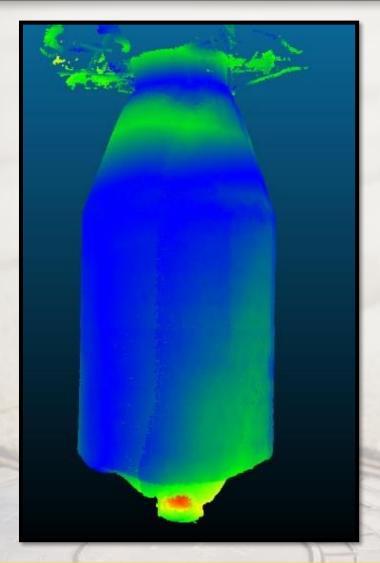
Manhole Rehab Quality Control

Comparison of two meshes provides distance deviation of entire structure using color grading

- Scan at failure
- Scan after pressure washing
- Scan after coating
- Scan at end of warranty period
