# Measuring the Effectiveness of Comprehensive Rehabilitation Recommendations

## Town of Saugus, MA

- Population: 24,000
- Land Area: 12 mi<sup>2</sup>
- 95 Miles of Sanitary Sewers
  - Divided into 27 Subsystems
- Pipe Materials
  - Vitrified Clay Pipe
  - Asbestos Cement
  - PVC
- Main Pumping Station – Lincoln Avenue P.S.

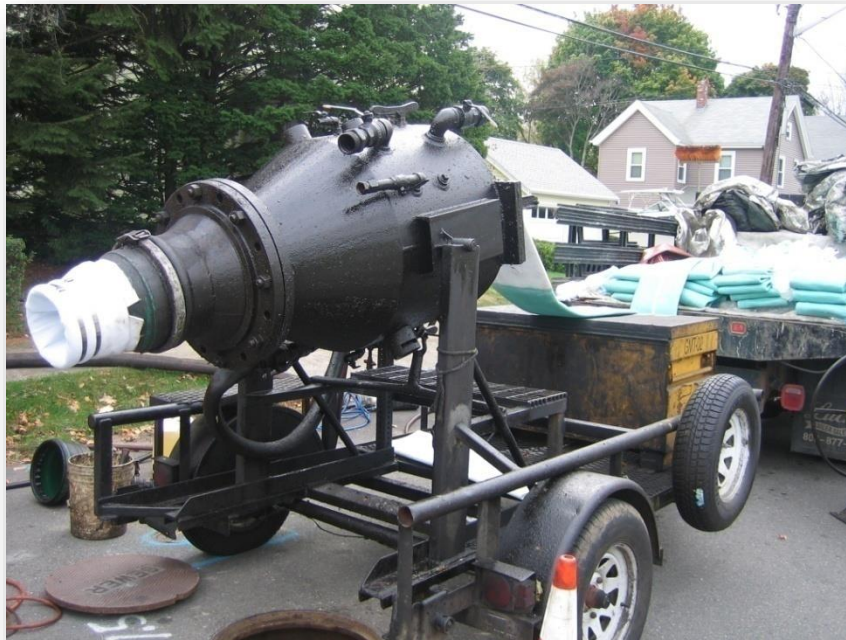
Inversion Process

## Cured-in-Place Pipe (CIPP) Lining

- Perform Comprehensive Rehabilitation of Public System
  - Cured-in-Place Pipe (CIPP) Lining
  - Manhole Rehabilitation
  - Service Lateral Connection Lining
- Of All Sewers and Manholes in a Subsystem

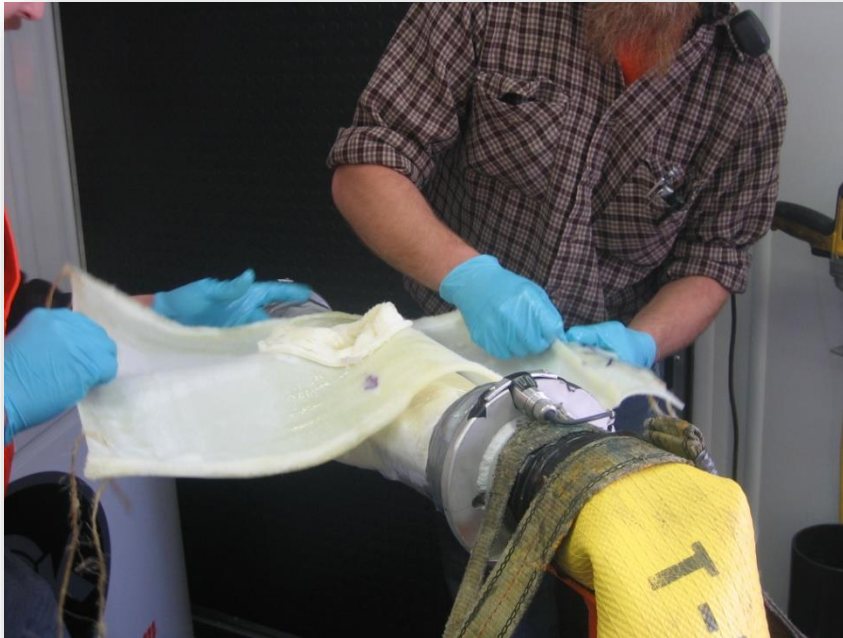
Preparation of Liner

## Service Lateral Connection Lining

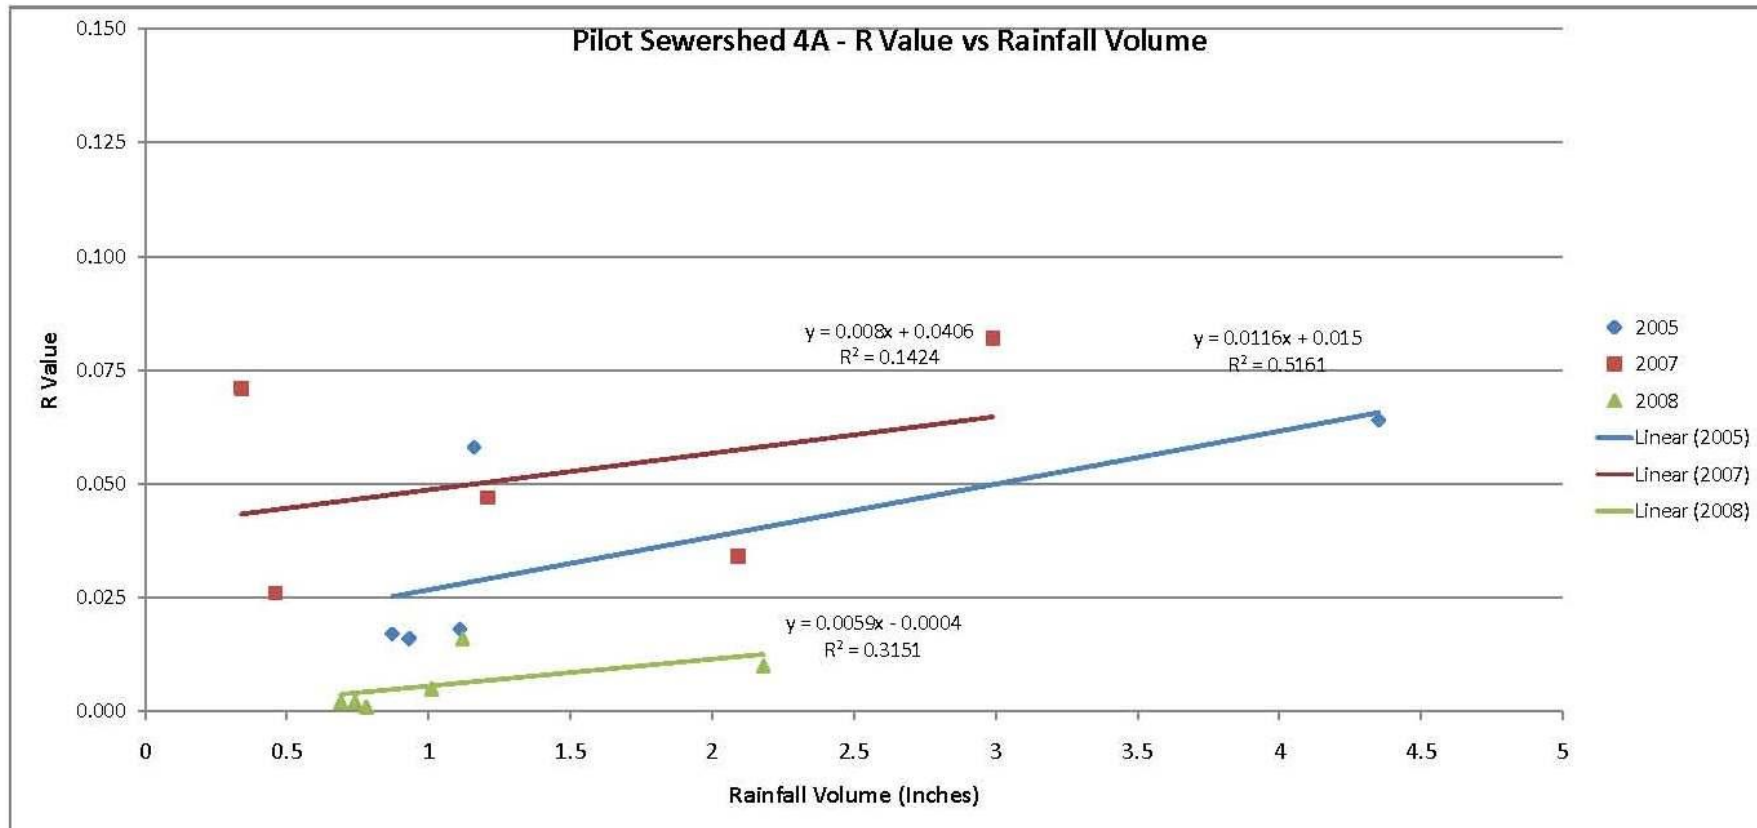
# Regression Analysis

- Re-Meter Rehabilitated Subsystem & Control Area
- Analyze Groundwater Conditions Pre- & Post-Construction
- Evaluate Changes in Control Area
- Perform Regression Analysis

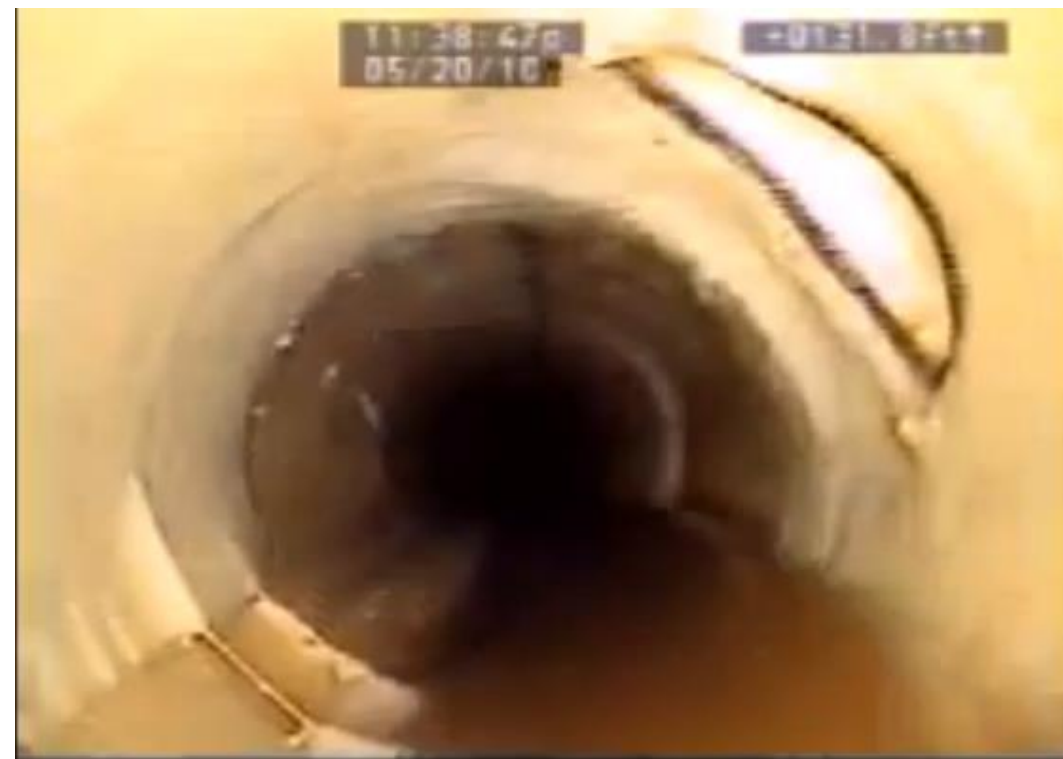
## Service Lateral Connection Lining

- Constructed Spring/Summer 2019
- 684 Laterals Lined
  - Full-Wrap in Main
  - 24-inches up Lateral

- Service Lateral Connection Lining Can More Than Double Infiltration Removal Volumes
  - Estimated 32% Additional Flow Removed
    - Mainline CIPP & MH Rehab: 23%
    - Service Lateral Lining: 32%
    - Average Removal %: 55%
- Post-Construction Regression Analysis in 2020 to Confirm Assumptions
