# Leading Practices for Cross Bore Risk Reduction

Mark H. Bruce, President  
Cross Bore Safety Association  
[mark.bruce@crossboresafety.org](mailto:mark.bruce@crossboresafety.org)  
[www.crossboresafety.org](http://www.crossboresafety.org)

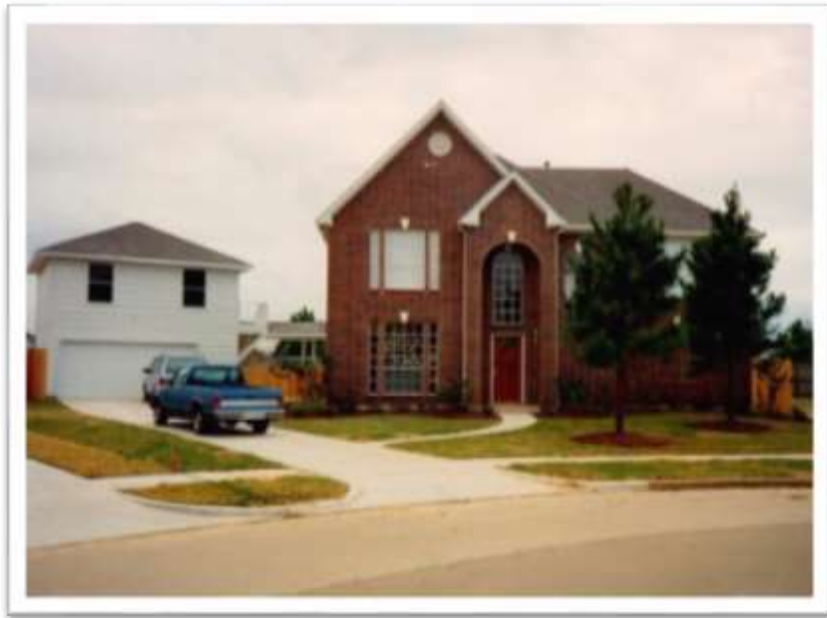
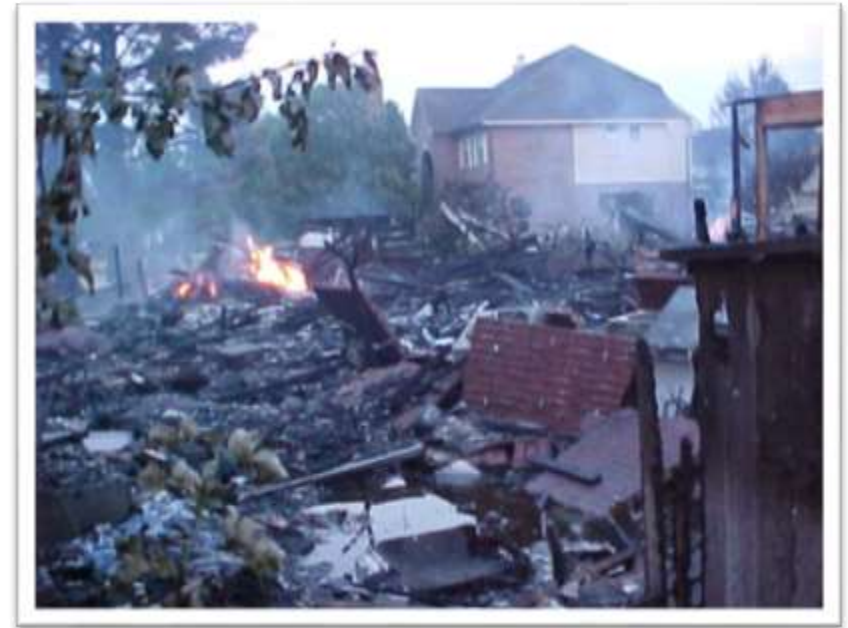
# Cross Bore Explosion - Class 2 Cross Bore

Before

After

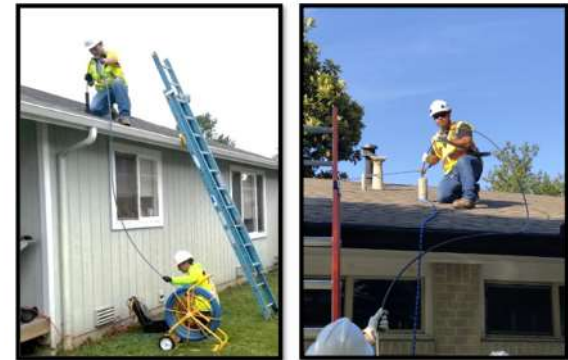
Figure 20: Roof vent inspection with manual push camera. Fall protection must be used according to safety regulations.

- iii. Roof vents. See Figure 19 for an illustration of vents and interior plumbing and sewer connections to the mainline.
- iv. Access to roof vents shall be according to OSHA requirements, see Figure 20 for an example of a push camera inspection from a house vent. See Chapter 23.

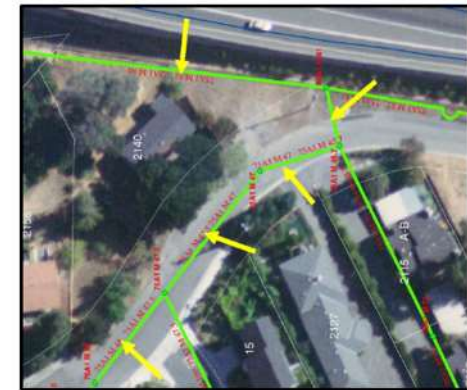
Figure 12: Parcel illustrating 5 mainline sewer segments that could have lateral connections to single structure

lateral launch cameras first as opposed to using manual push cameras, since this method more easily identifies lateral taps. Extra care must be taken by manual push camera technicians to verify that all laterals are traversed beyond the risk of cross bore with the existing utilities, see *Figure 10* and *Figure 12*.

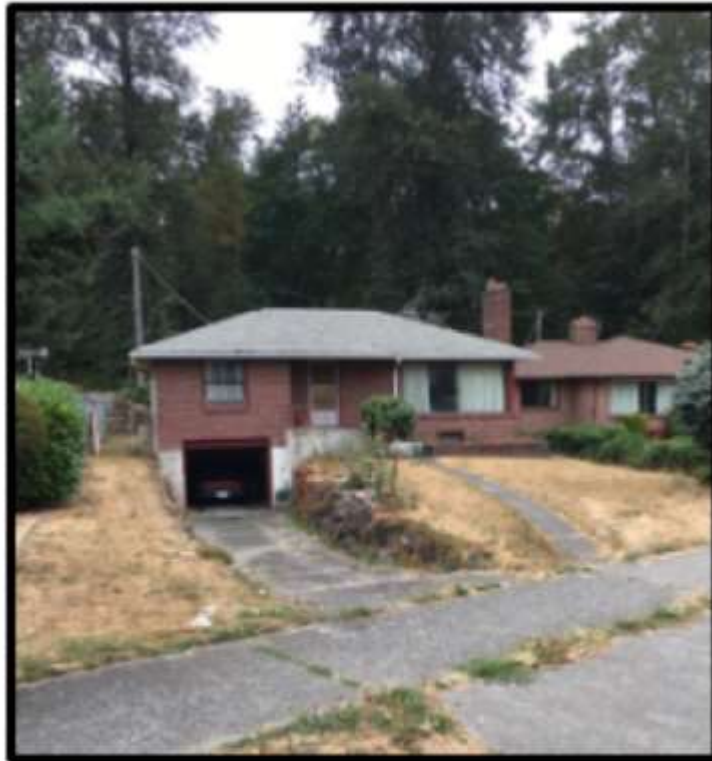
**Figure 22: Example of property with determination made using surface elevation on the site**

- v) An illustrative proximity determination example follows, see Figure 22.
  - (1) The sewer exits on the left side of the house and the sewer tap was previously navigated on the left side of the structure, but the CCTV vision was impaired or a portion of the sewer line was not able to be traversed, and;

*Figure 22: Example of property with determination made using surface elevation on the site*

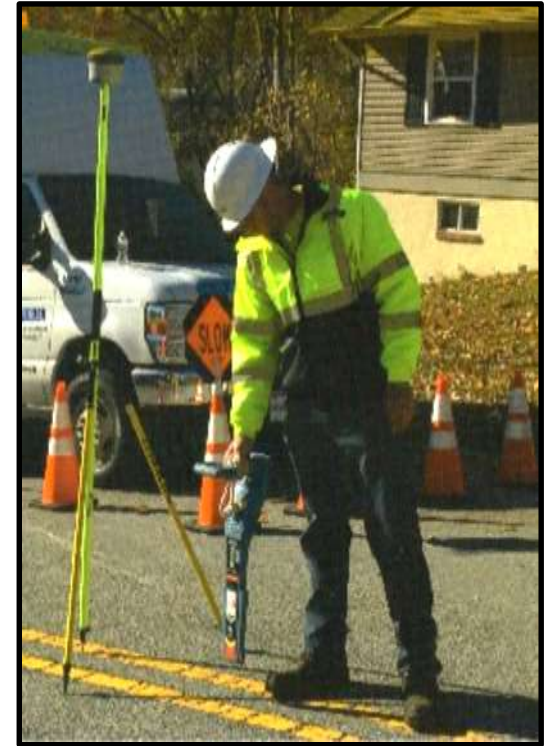
# GPS / GIS Mapping

- Recommended GPS Accuracy - better than 12" equipment
- Requires differential correction capability
- Differential correction is free in some states using mobile internet connections
- Frequently achieve 4" (10 cm) accuracy
- Use offsets to accommodate multipath from reflected GPS signals
- Urban canyons are difficult to achieve 12" accuracy

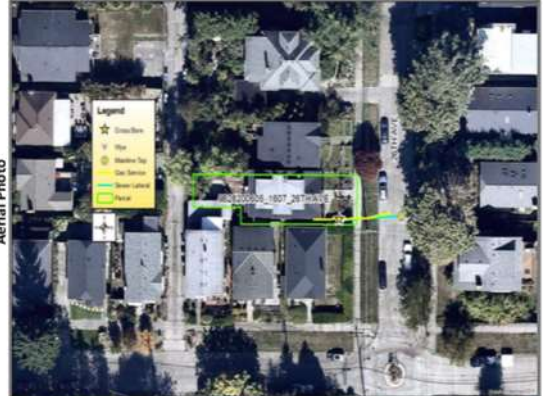
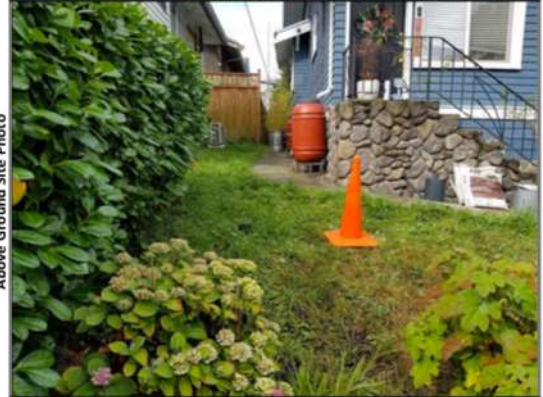
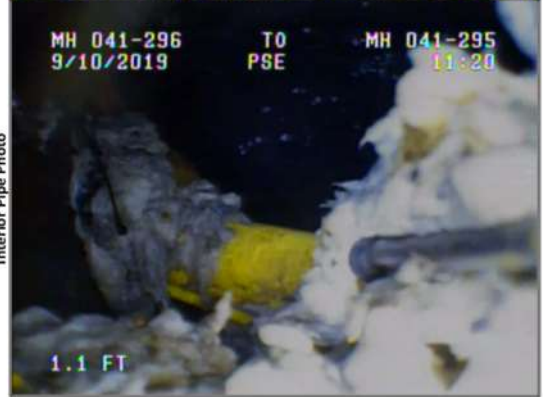
| Cross Bore Report | |
|---|---|
| GFR Tim Peterson on site. Wye is ~43.9' from MLT. Cross bore is ~1.1' from beginning of wye | |

**Aerial Photo**

**Above Ground Site Photo**

**Interior Pipe Photo**
