Data Quality Evaluation Processes for PACP Inspection Data

Hossein Khaleghian

Yongwei Shan, Ph.D., P.E.

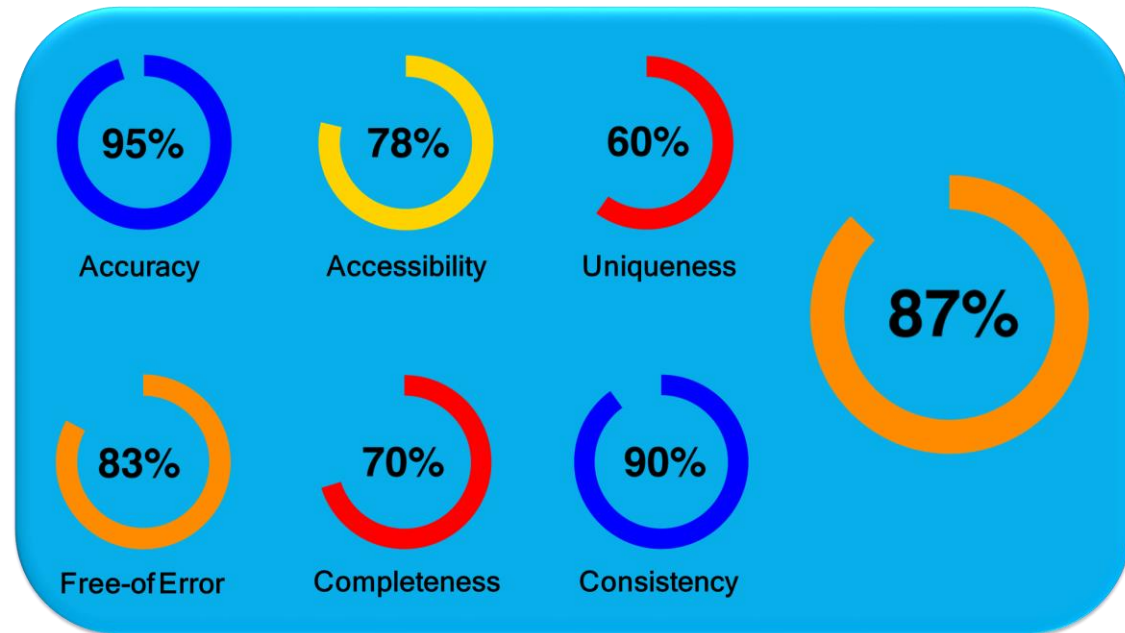
- Problems with data that deserve review:

- Missing Information
- Redundancy
- Accuracy
- Inconsistency

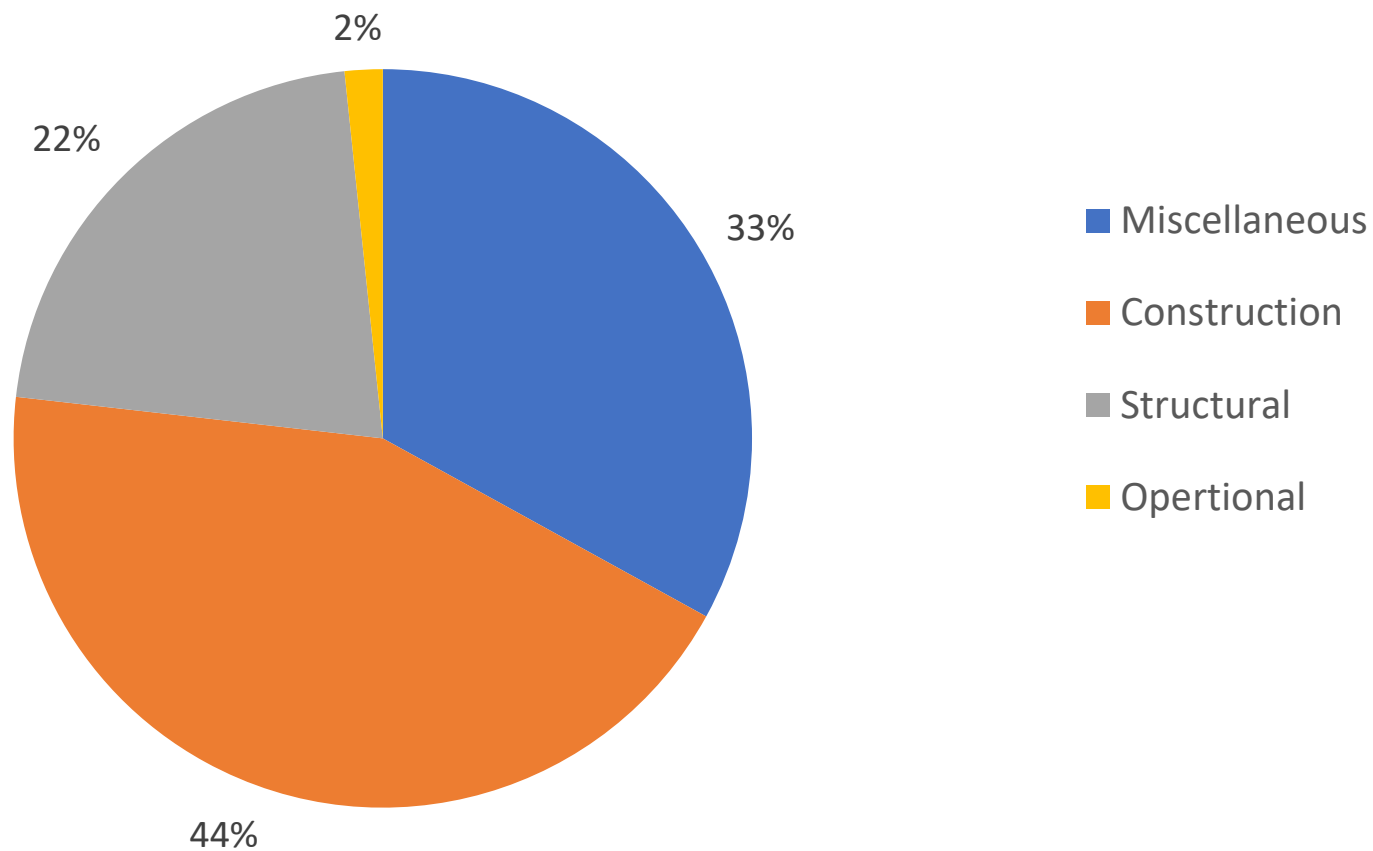
Defect Groups

- **OBSERVATION Table provides some information on the conditions (724 rows):**
 - **Code**
 - **Distance**
 - **Clock Positions**
 - **Severity**

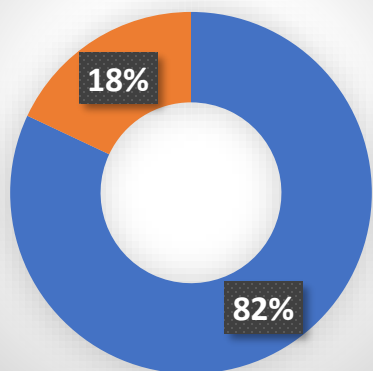
Completeness

Data Quality of the Defects
