Lessons Learned During Trenchless Planning, Design, and Construction

Kim Hanson, PE Hazen and Sawyer

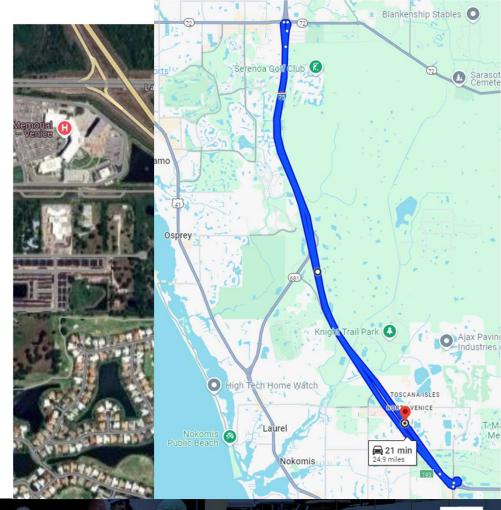
Project Example – Venice, FL

- New FM under I-75
- Microtunneling under travel lanes
- Open cut in median
- Access to median from NB lanes only

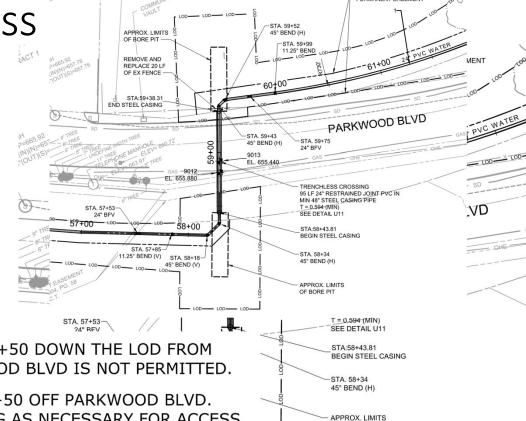
Project Example – Frisco, TX

- New 24" water main
- Several trenchless crossings

- 2. CONTRACTOR TO ACCESS BORE PIT AT \sim STA 58+50 DOWN THE LOD FROM EUBANKS STREET. DIRECT ACCESS OFF PARKWOOD BLVD IS NOT PERMITTED.
- 3. CONTRACTOR TO ACCESS BORE PIT AT ~STA 59+50 OFF PARKWOOD BLVD. CONTRACTOR TO REMOVE AND REPLACE FENCING AS NECESSARY FOR ACCESS.

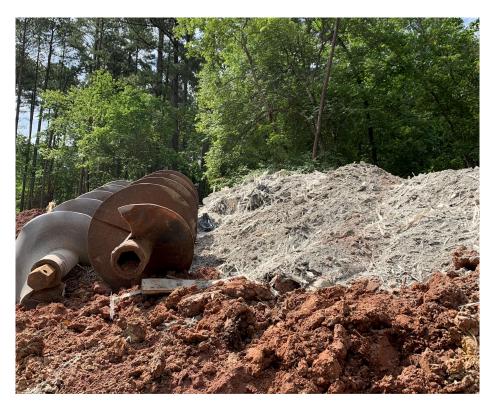
Collapsed Pipe – North Carolina

- Pumped heavy-weight flowable fill
- Pumped in single lift
- Pumped fast
- Only a single 1-inch vent

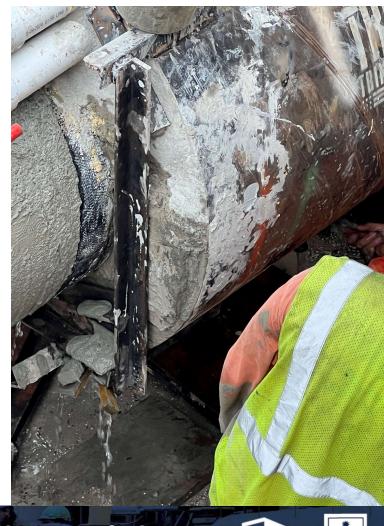
Water-filled Annular Space

- Watertight casing initially dry space
- Backfilled reception shaft
- Turned off dewatering
- Groundwater seeped through the bulkhead and filled annular space
- During grout placement started getting water through bulkhead

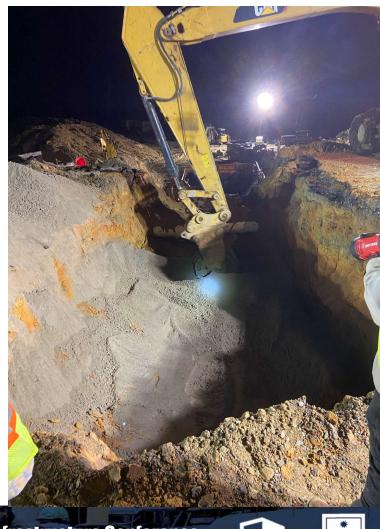
Project Example – North Carolina

- 5 miles of large-diameter sewer with two 120-inch tunneled crossings
- Pipe jacking + hand mining at face using sand shelves and breasting boards
- No fulltime or specialty inspection
- Sudden in-rush of material inside tunnel
 → significant road settlement

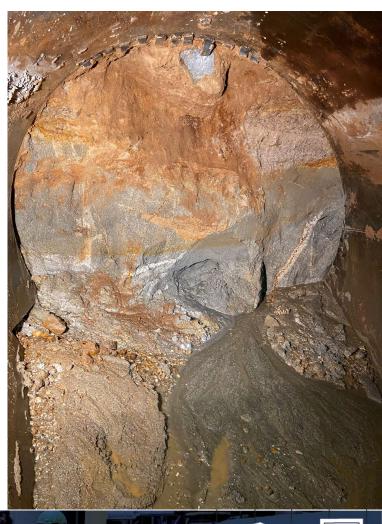
Project Example – North Carolina

- Contractor onsite that evening claimed different site conditions than anticipated
- Investigation shows they weren't following submitted procedures
- No onsite documentation

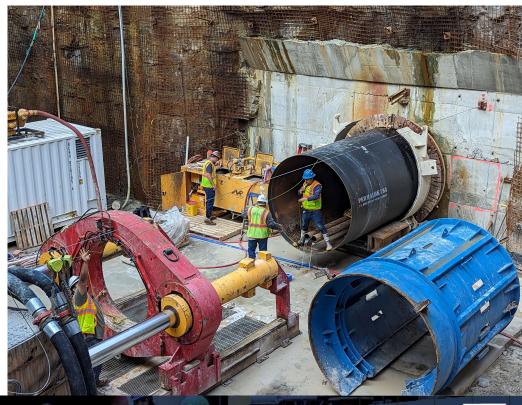
Project Example - Tennessee

- Fulltime inspection
- Detailed daily reports
 - ✓ Tracked time spent on activities
 - ✓ Observations by inspector
 - ✓ Notes about contractor's efforts
 - ✓ Photos

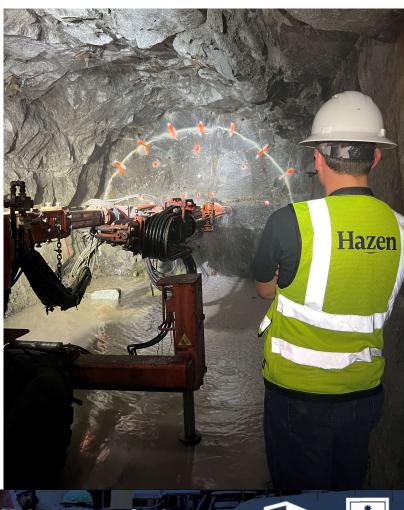
Project Example – Virginia

- 12-foot horseshoe drill and blast tunnel
- Fulltime resident observation
- Facilitated better communication and collaboration
- Reduced downtime
- Prevented rework

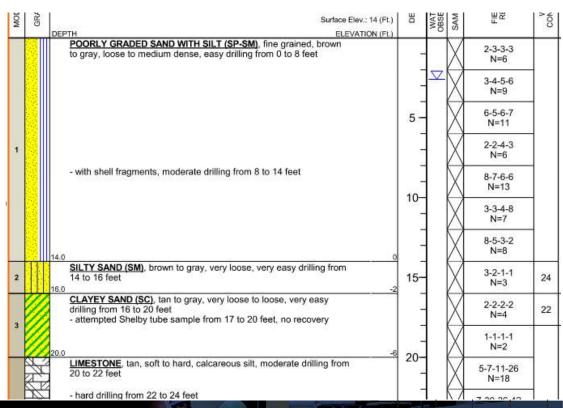
Geotechnical Investigation Scoping

Guidance for borings:

- Depth
- Rock coring
- Continuous sampling
- Surveyed elevations
- Lab testing
- Rock core storage

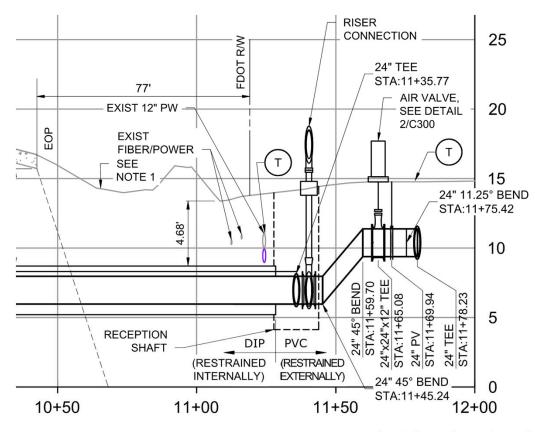
Project Example – Florida

- Existing 12" PW deeper than expected
- Require rerouting before tunnel construction
- Cost impact: Four 45 bends
 & labor/equipment
- Schedule impact: None

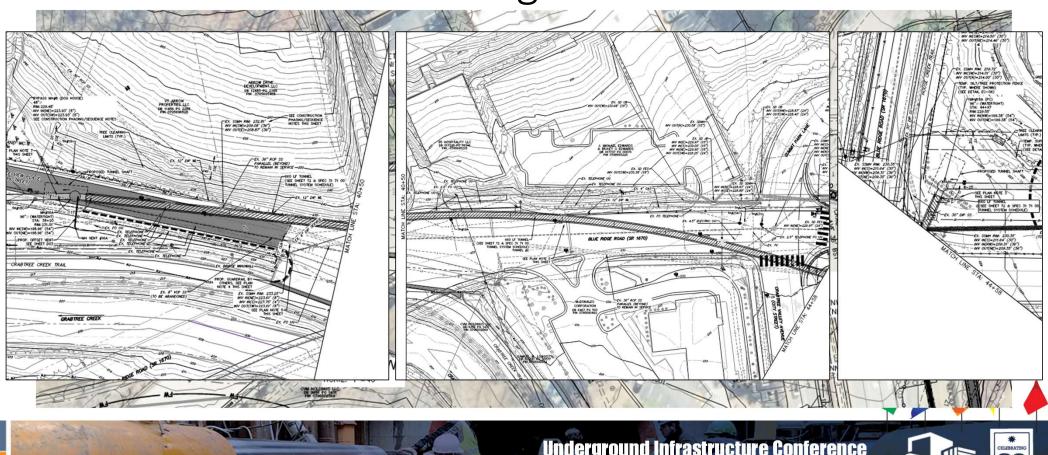
Information on Drawings

- Note: Access road to reception shaft is prone to flooding during significant rain events. Contractor to maintain safe access to the work site.
- Note: Access to the middle portion of HDD alignment is severely restricted and requires specialized equipment or temporary bridge structure.
- Note: Steep entry angle required to pass below existing sheet pile bulkhead. Tip of sheet piles estimated at Elevation -34. See Record Drawings in Appendix A.
