# AI-Powered Rapid Manhole Inspection

Combining 360° Scanning with AI for Automated Asset Assessment

Jinwu Xiao, Wei Liao, Tom Iseley  
Purdue University

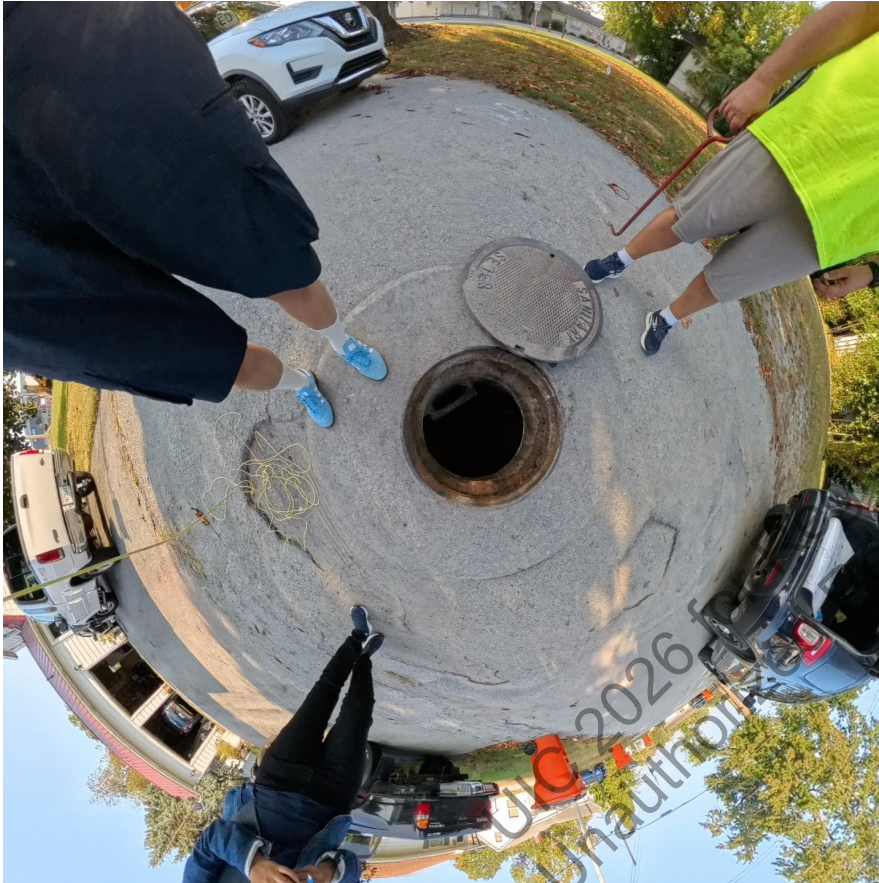
# Rapid 360° Data Capture

~15 SECONDS  
Per manhole capture time.

- Handheld Operation: No tripods.
- Motion Robustness: Stabilized capture.
- Minimal Setup: Open and deploy.

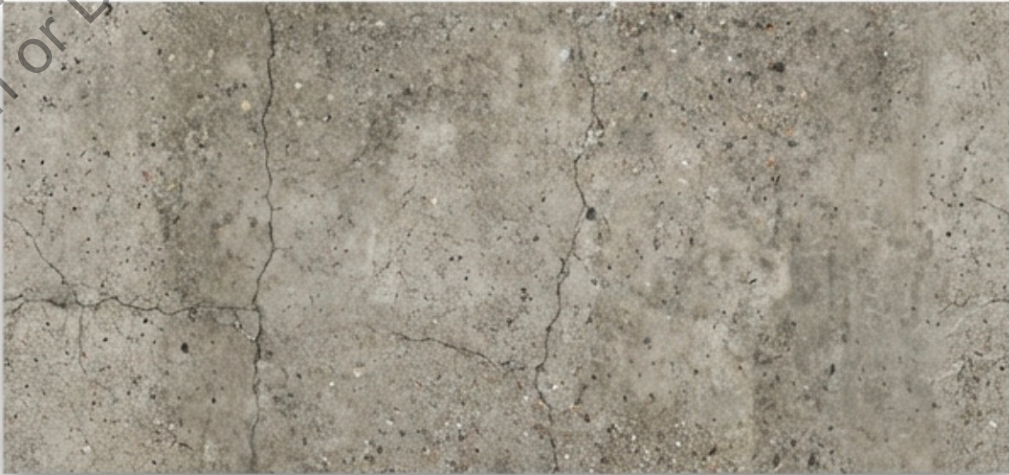
# The Digital Transformation: 3D to 2D

Unfolding the geometry for standardized analysis

Geometric Transformation

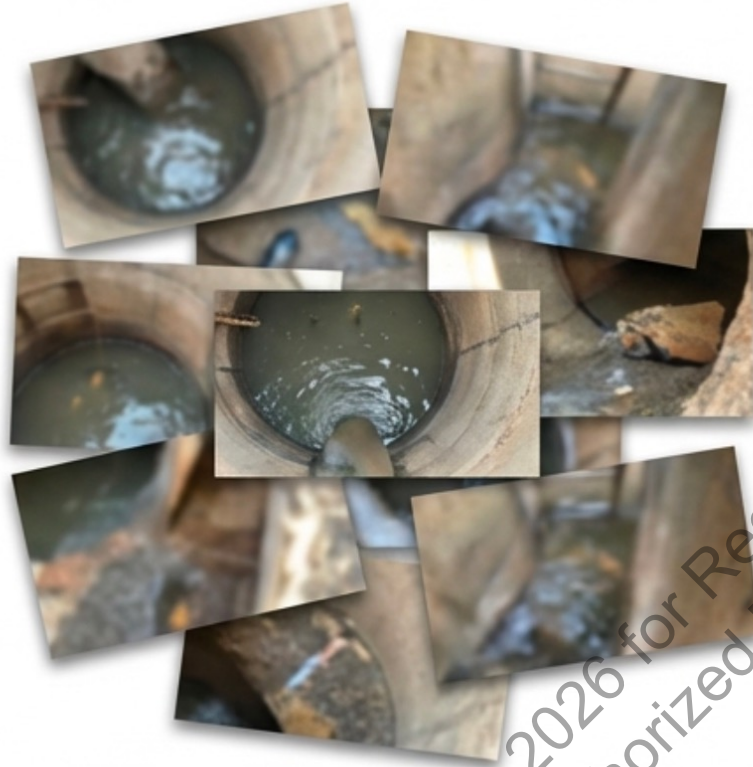
Raw Video Frames (Fragmented & Variable)

Standardization eliminates variability, creating the perfect dataset for Large Language Models.

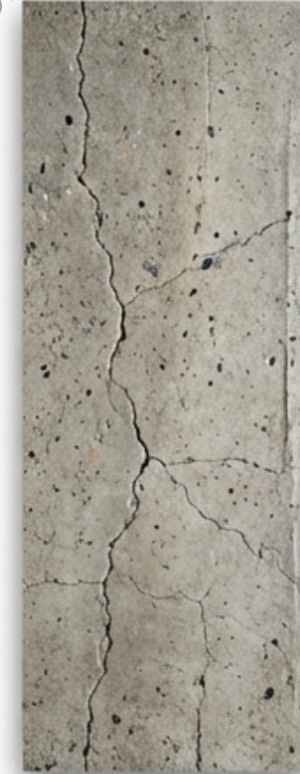
Unfolded Image (Structured & Consistent)

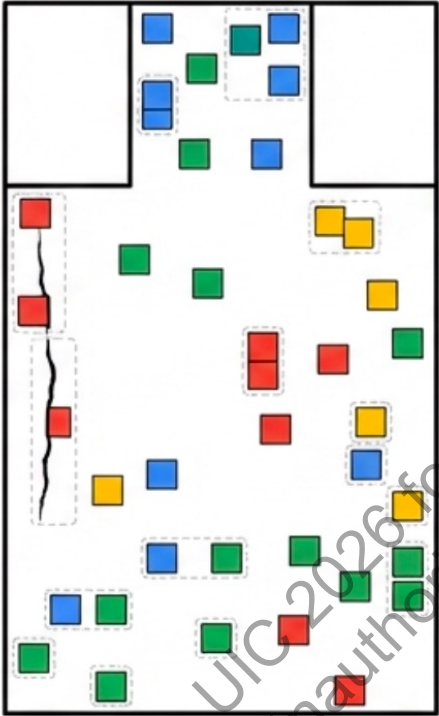
Phase 1: Visual Clustering (Pre-AI)

Grouped by proximity (DBSCAN)

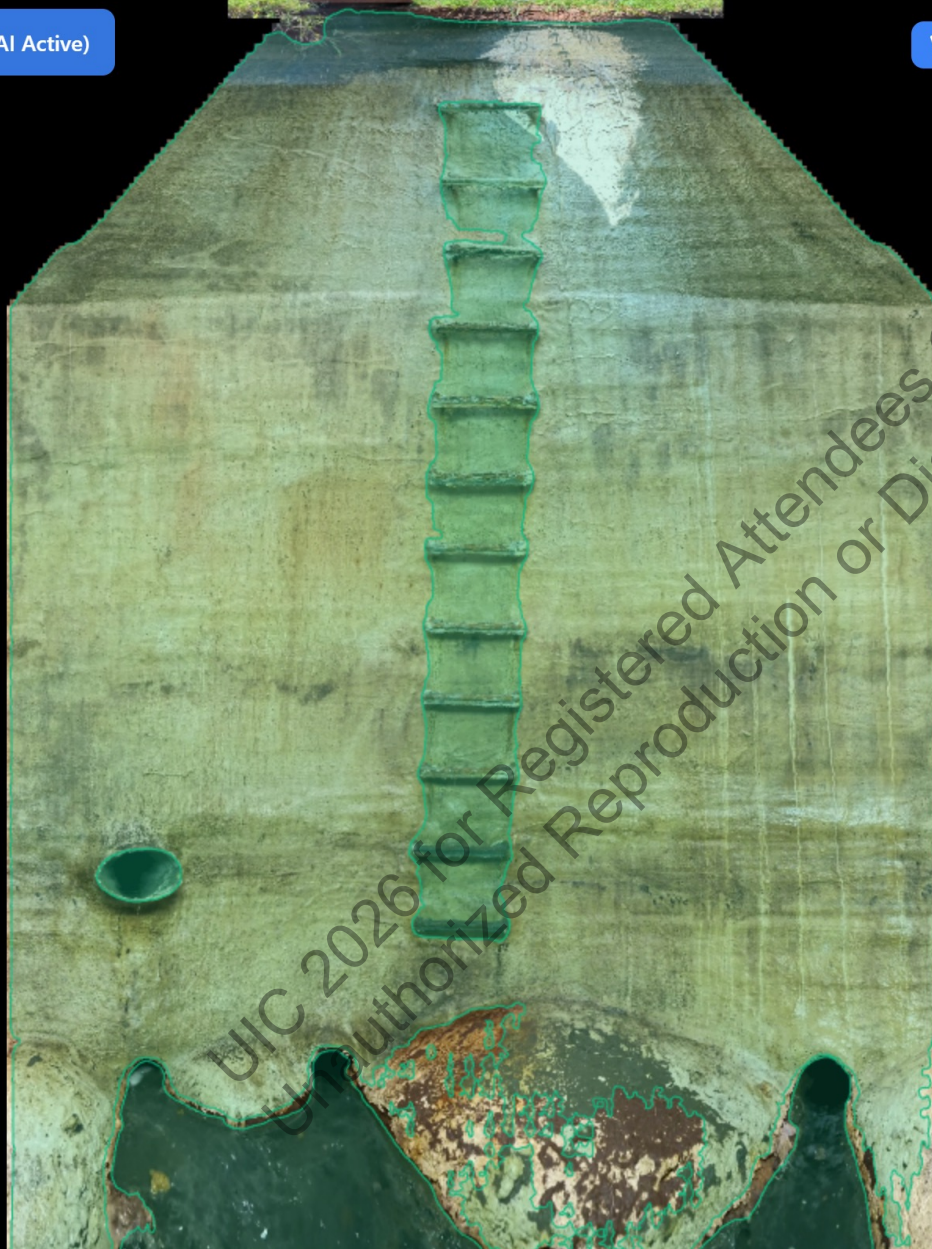
5 areas • 1726850 px<sup>2</sup>

● **CO** Sev: 2

Area: 1498396 px<sup>2</sup> • 99.8% AI: 95%

The interior concrete surfaces exhibit widespread moderate surface corrosion with significant discoloration and exposed aggregate across the wall and cone sections.

Area: 121877 px<sup>2</sup> • 91.6% AI: 95% Step

A vertical series of manhole steps exhibiting advanced surface corrosion and oxidation throughout the highlighted section of the wall.

A circular hole is visible in the wall interior, representing a significant breach where wall material is missing or a pipe is recessed.

Significant surface corrosion and mineral deposits are visible on the bench area, characterized by rough texture and white encrustation near the channel.

The interior wall area surrounding the pipe penetration shows significant corrosion with substantial surface material loss and exposed aggregate.

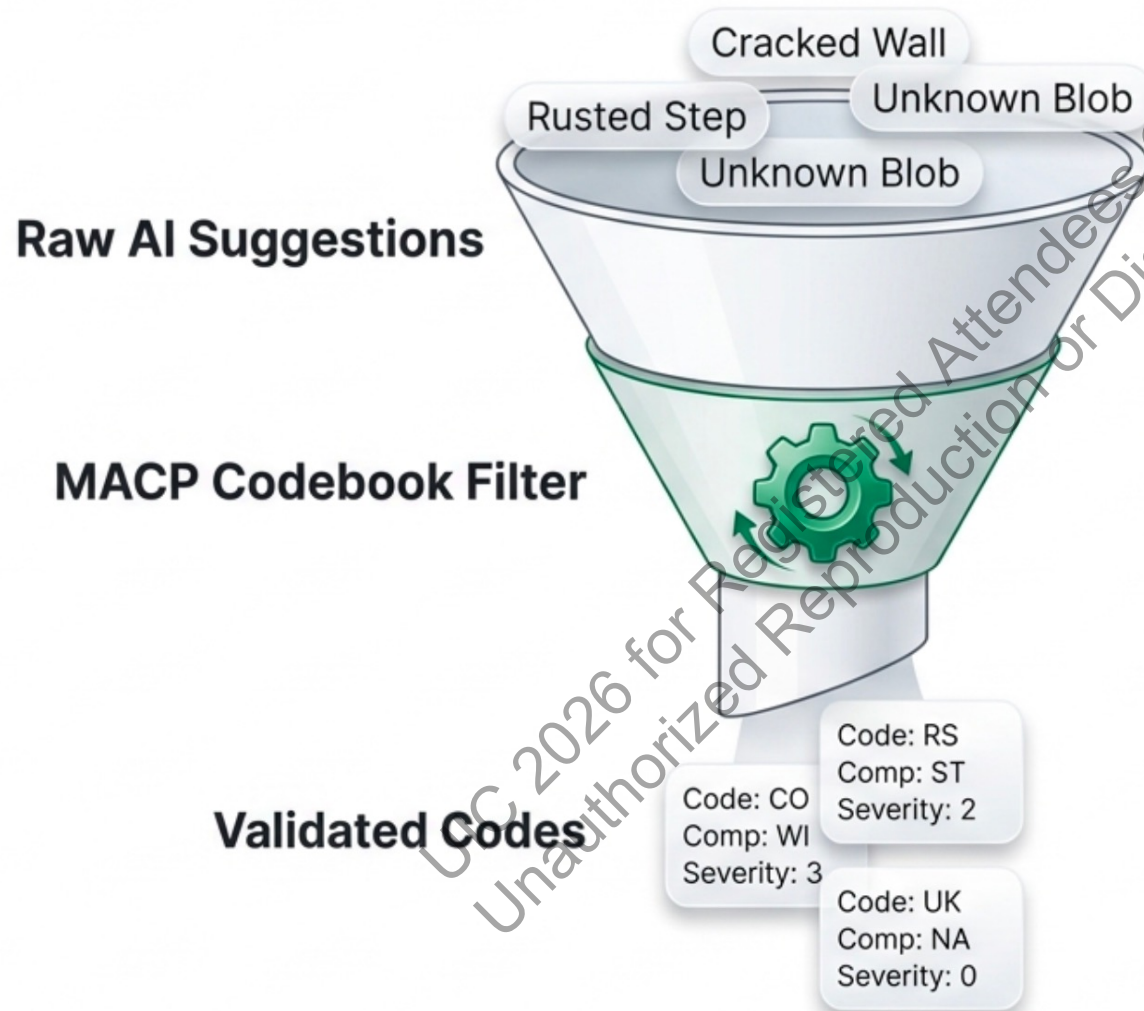
# Step 3: The Law (MACP Rules Engine)

- **Closed-Set Classification:** Invalid codes auto-corrected to "UK" (Unknown).
- **Logic:** Enforces NASSCO standards. A frame defect cannot exist on a bench.
