THE **UNDERGROUND** UTILITIES EVENT

# THE IMPORTANCE OF PROPER INSPECTION

Rocky Capehart

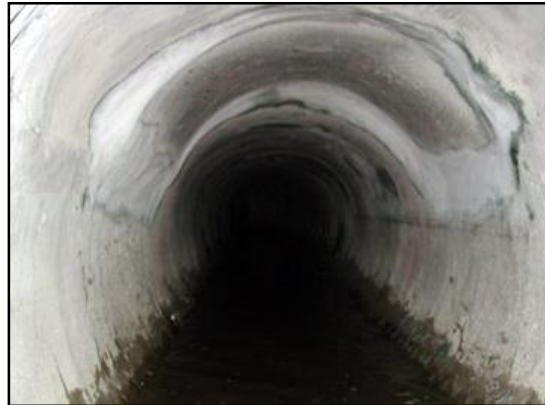
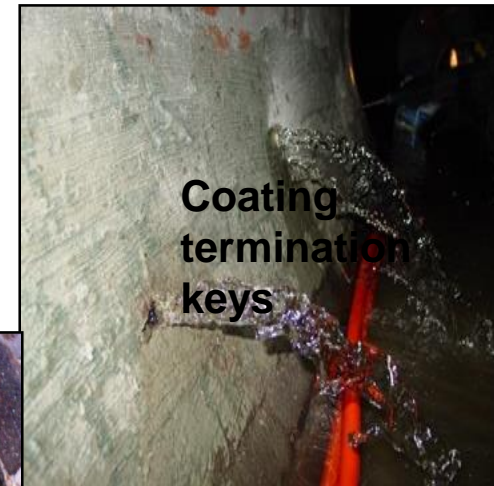
## KEY FACTORS FOR PREP SUCCESS

**Obtain a clean, dry and sound surface!**

- Understand repair procedures:
  - infiltration or substrate loss
- Understand preparation procedures
- Know how to test preparation results
- Know common methods of:
  - cleaning power
  - abrasive choices
  - coating removal

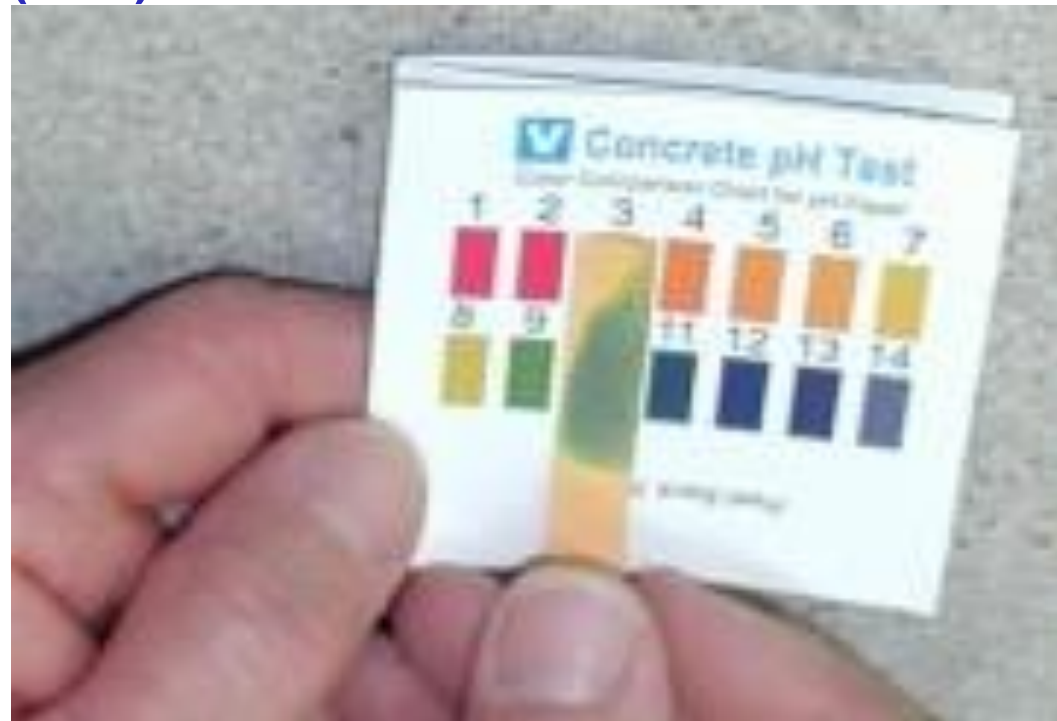
## pH TEST

Complications with a product application may occur if pH levels (number designation) are:

- high (alkaline)
- low (acid)

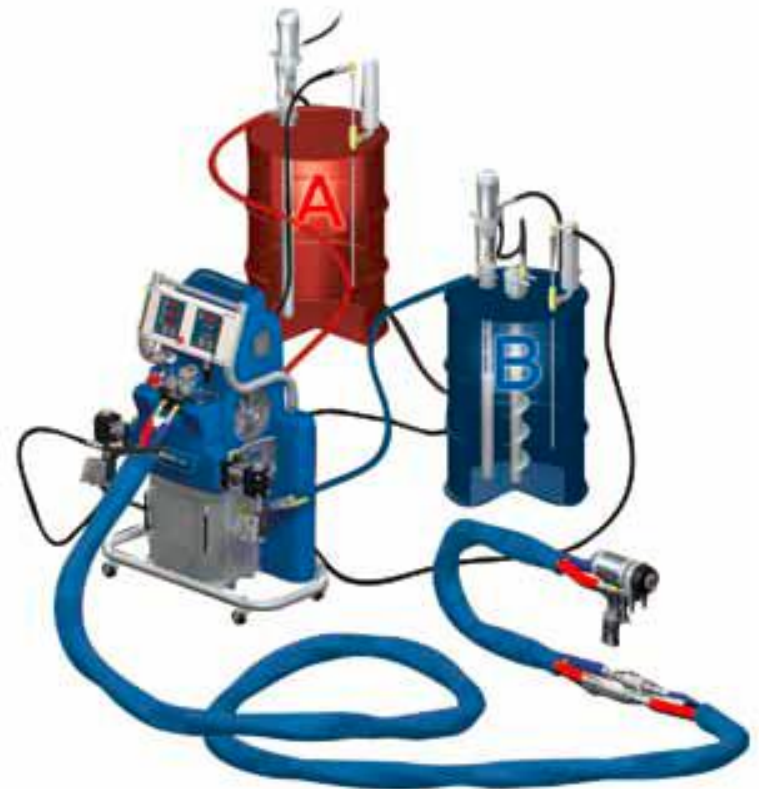
## EQUIPMENT

- Equipment is product dependent
- Some can be mobilized into underground structures as necessary
- Material output is meeting proper ratio

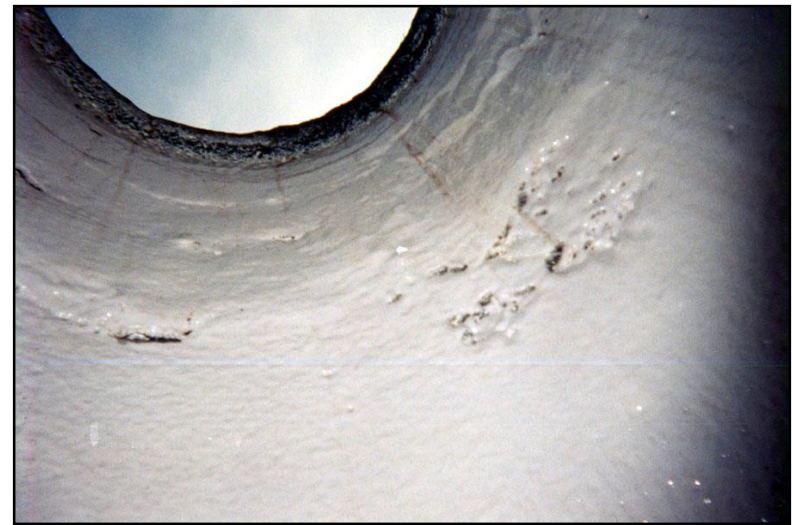
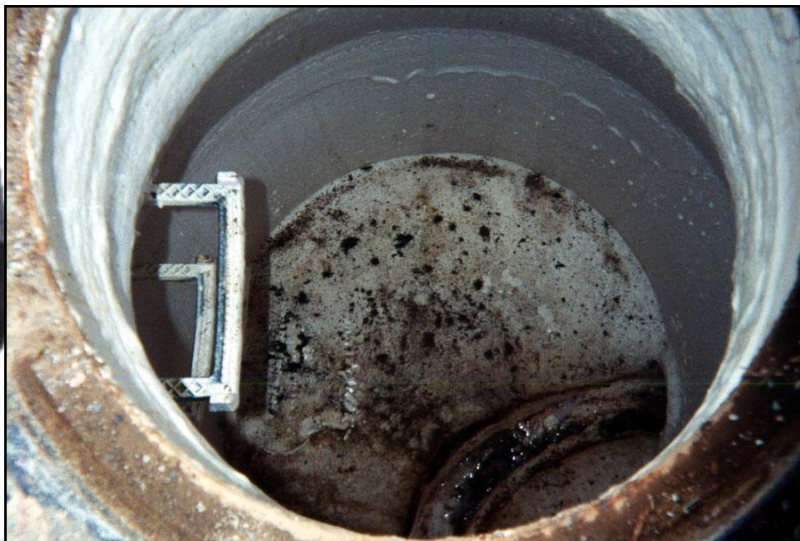
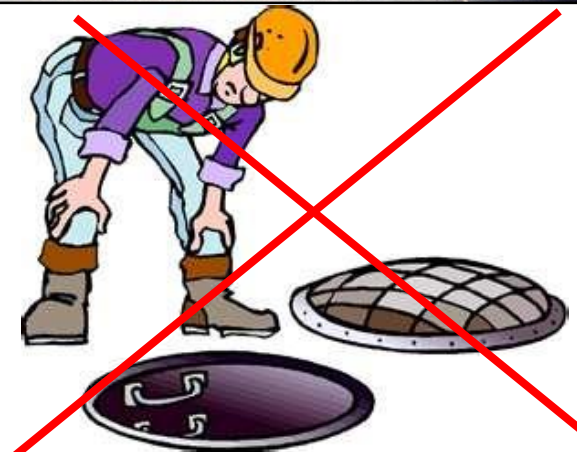
## VISUAL INSPECTION

- Cracking, pinholes, exposed substrate
- Proper bench and invert rebuild
- Frame/chimney sealing
- Pipe joint seals
- Step removal or replacement

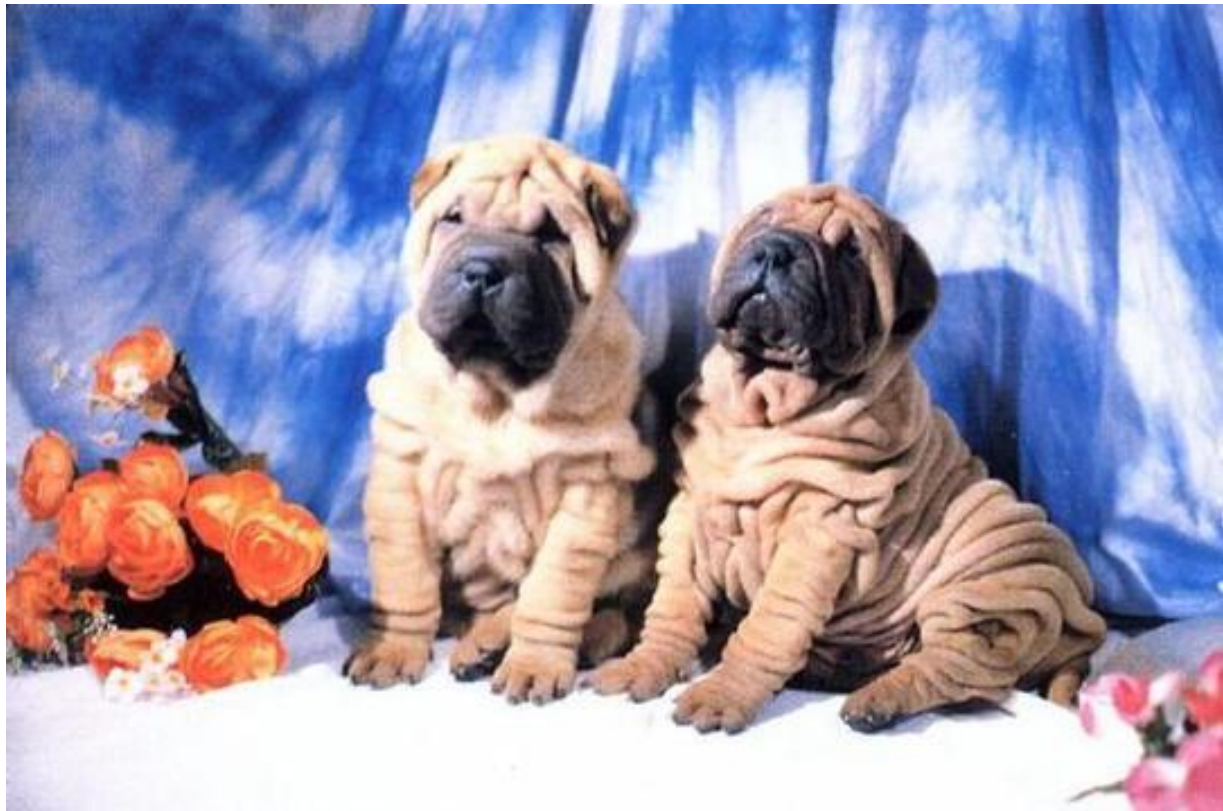
## WRINKLES & SAGS

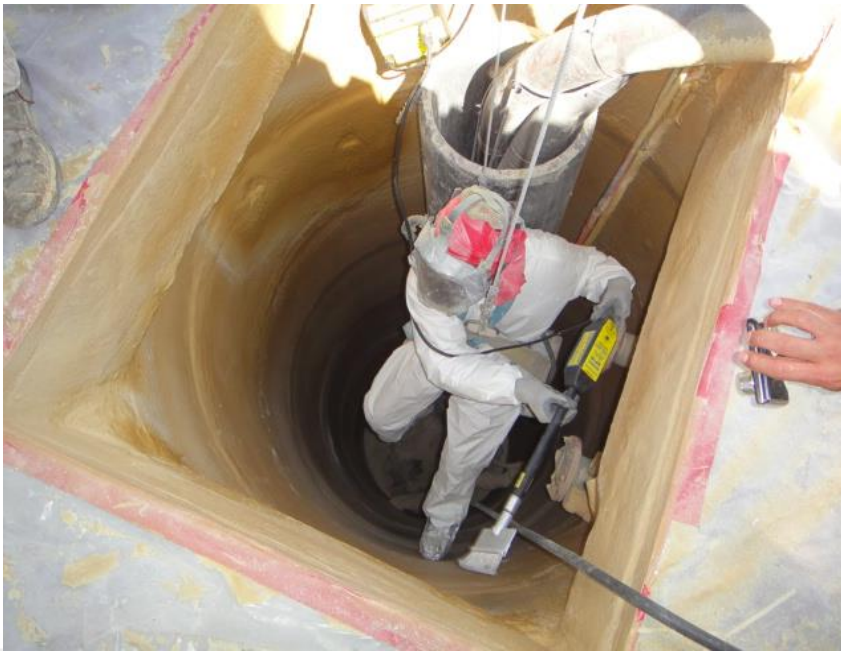
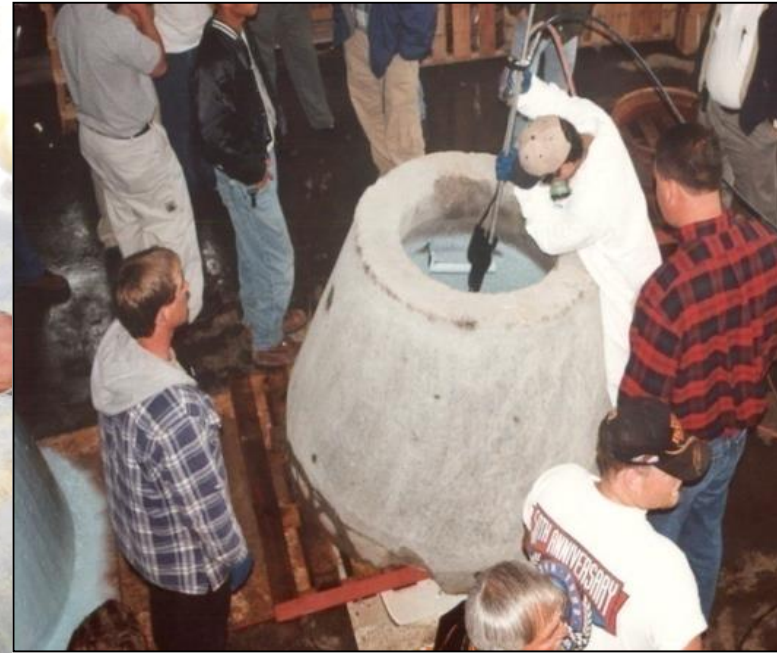
### Holiday (Spark) Testing

A barrier without fault provides effective long-term elimination of infiltration and corrosion protection

**Refer to NACE RPO188-Concrete & Steel**

**Refer to ASTM G627-87-Steel Pipe**

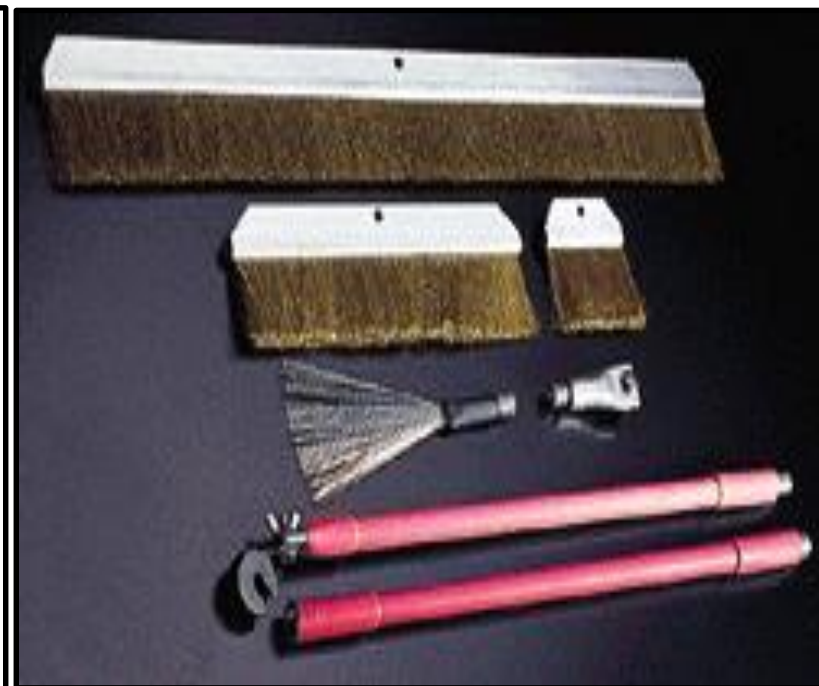
## HOLIDAY (SPARK) TESTING EQUIPMENT

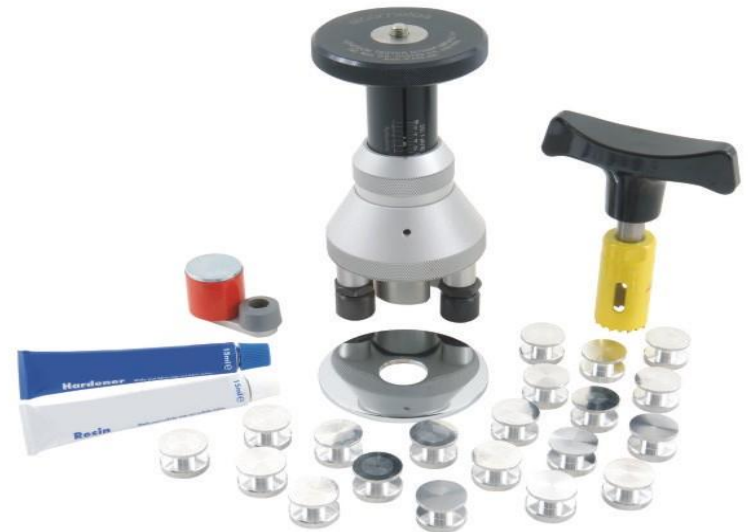
## ADHESION (PULL) TESTING EQUIPMENT

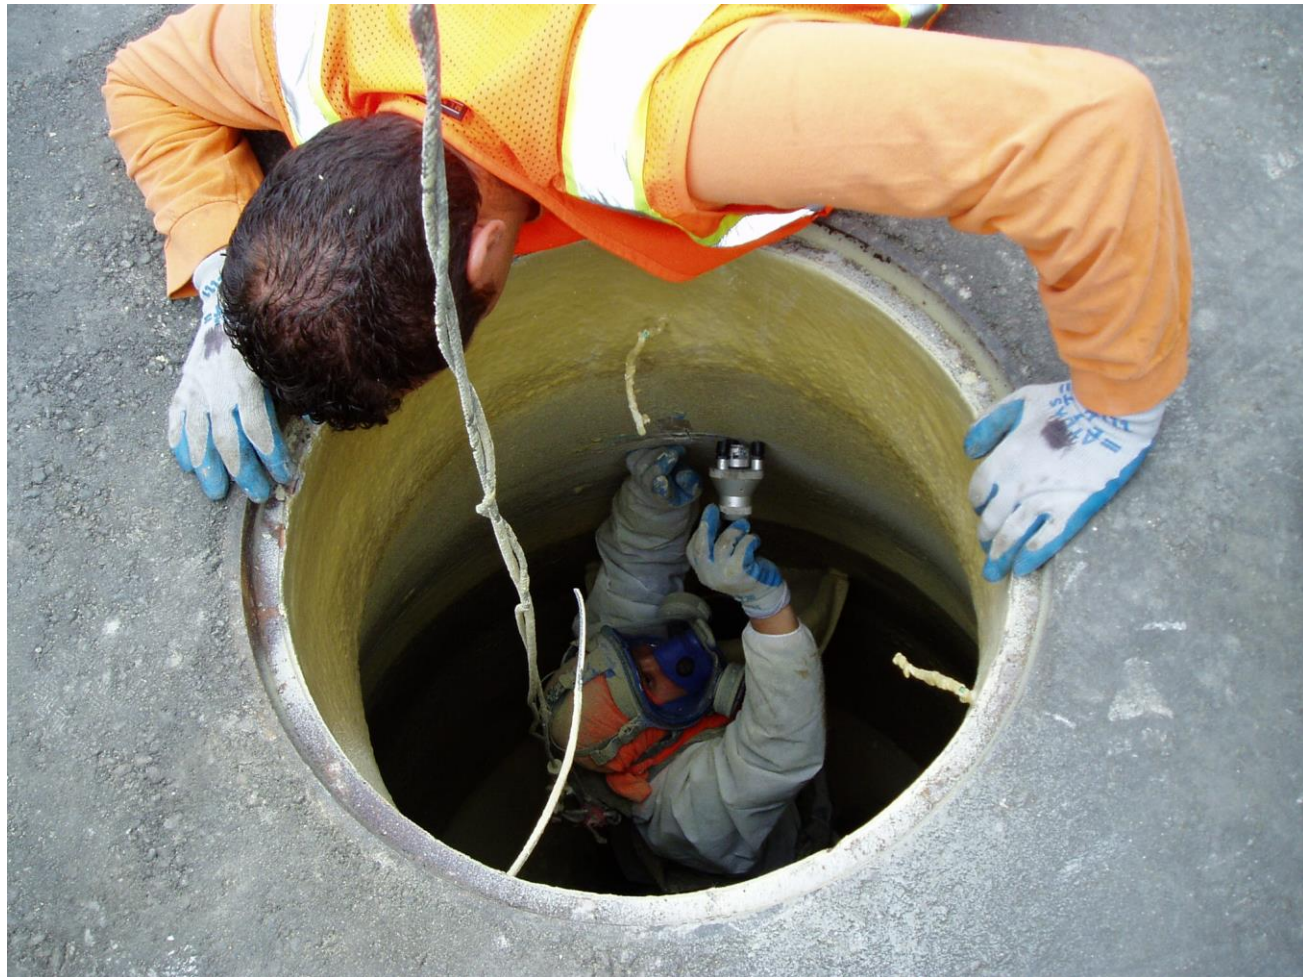
## ADHESION (PULL) TESTING

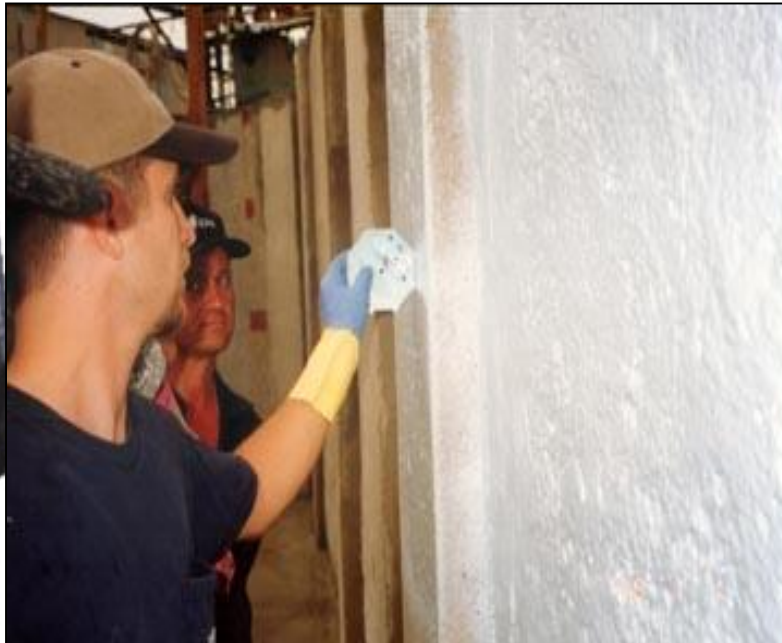
**WFT**

**Wet Film Thickness  
(Slow Setting Coatings)**

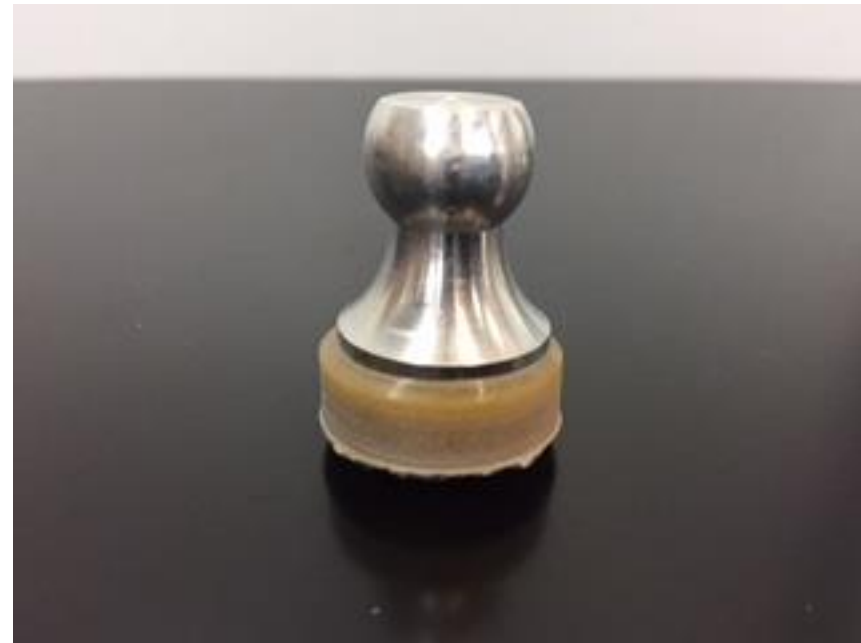
**DFT**

**Dry Film Thickness  
(Fast Setting Coatings)**

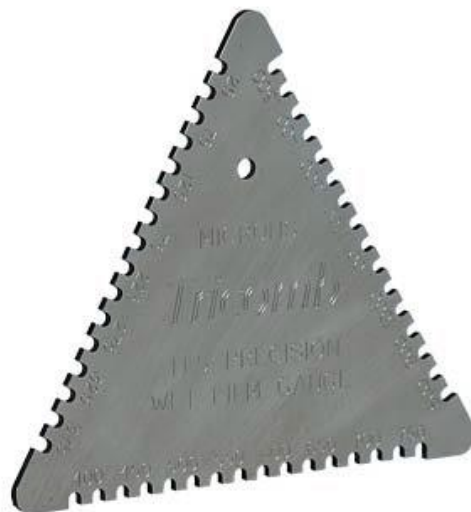
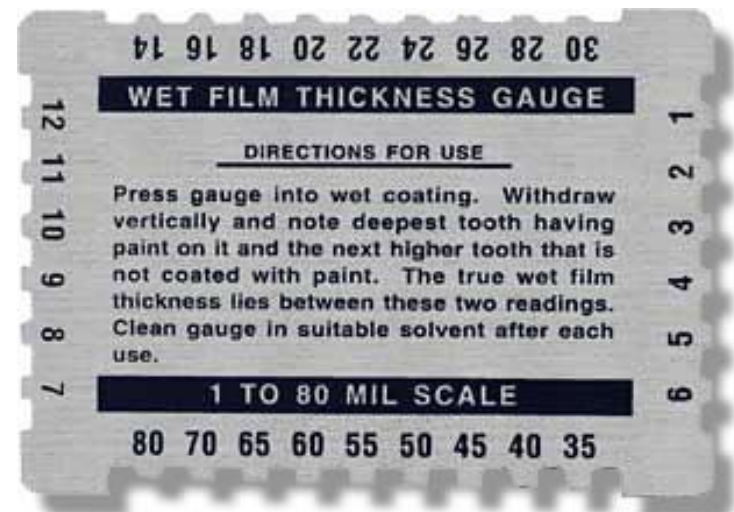
## COATING THICKNESS GAGES

### WFT

### Wet Film Thickness (Slow Setting Coatings)

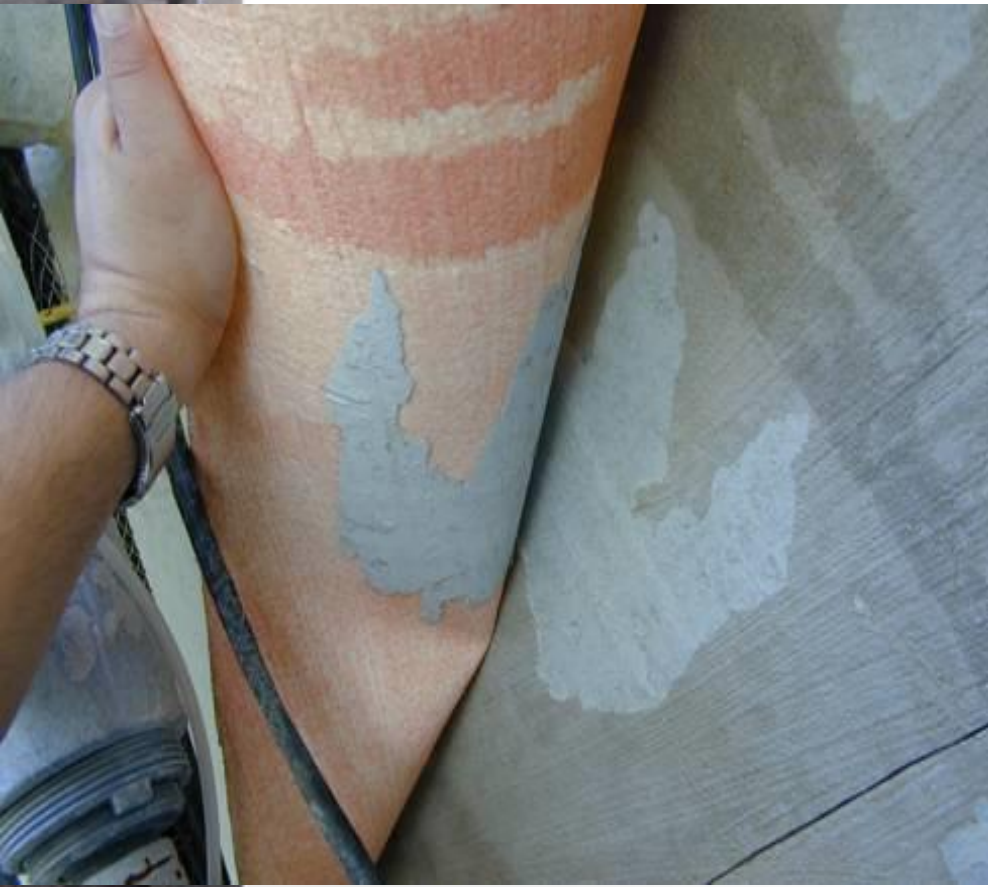
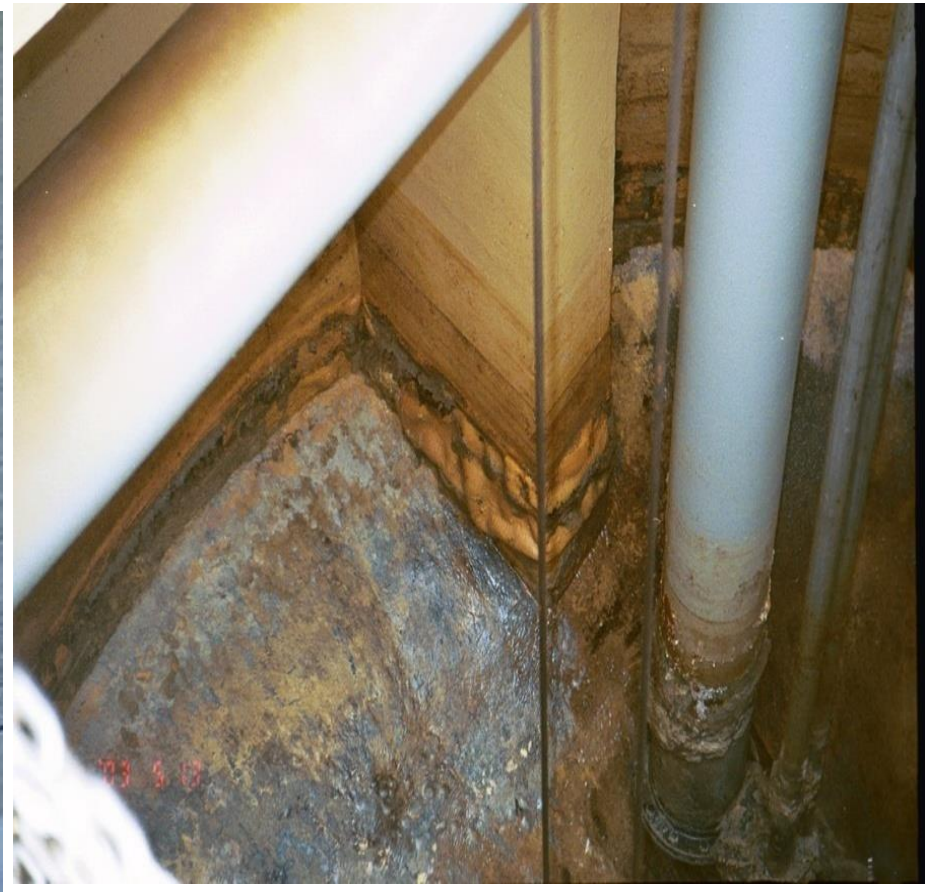
## LINER DISBONDING

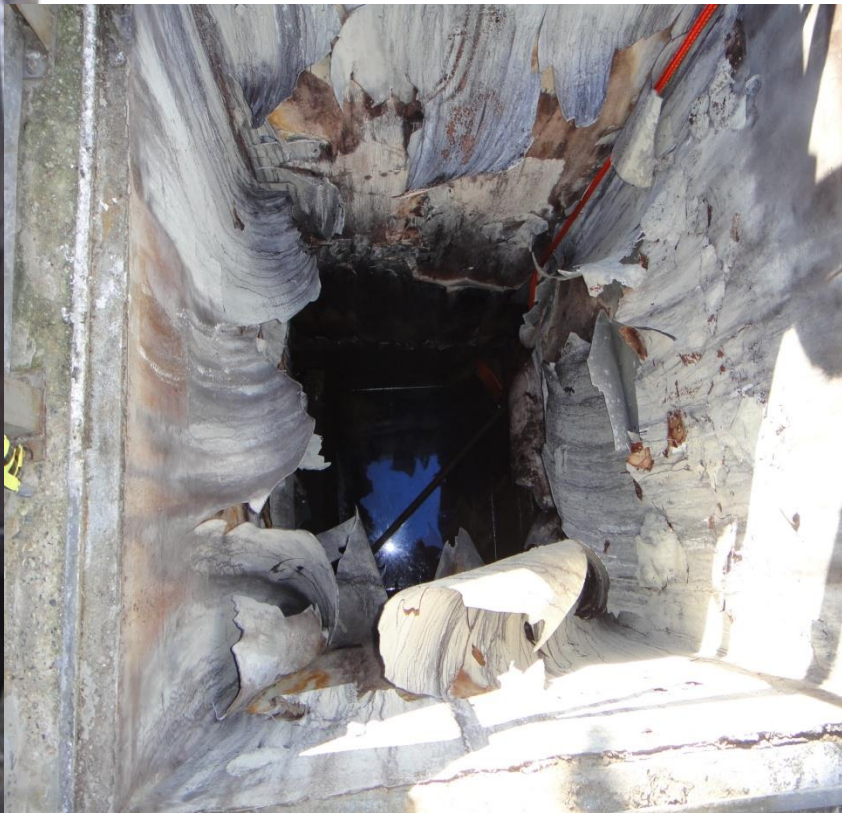
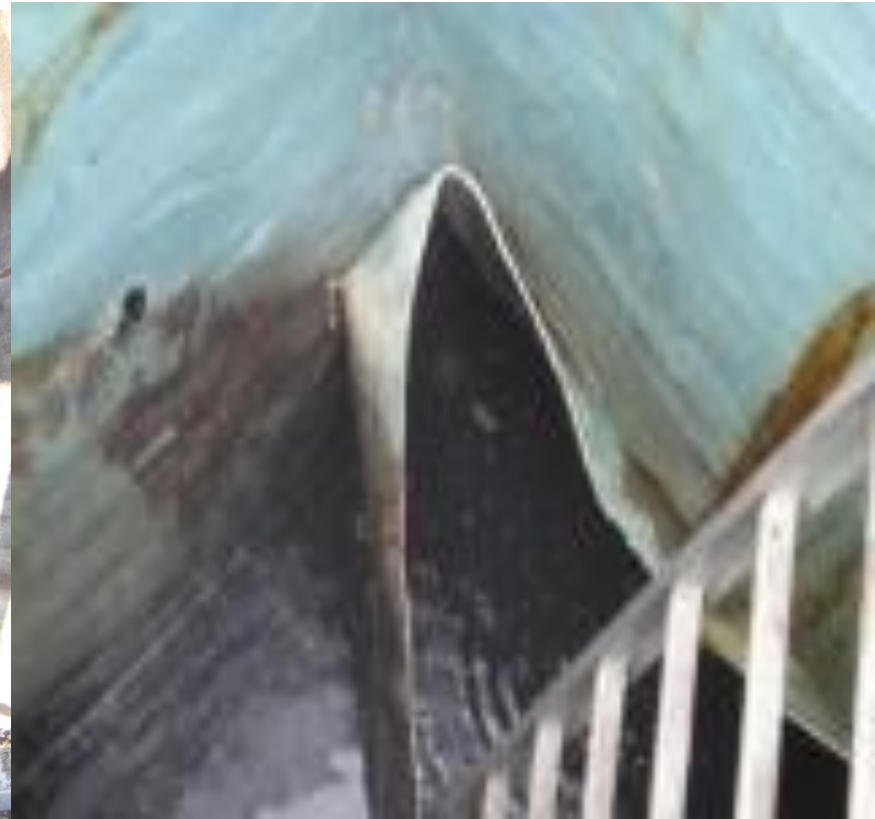
## LINER DISBONDING

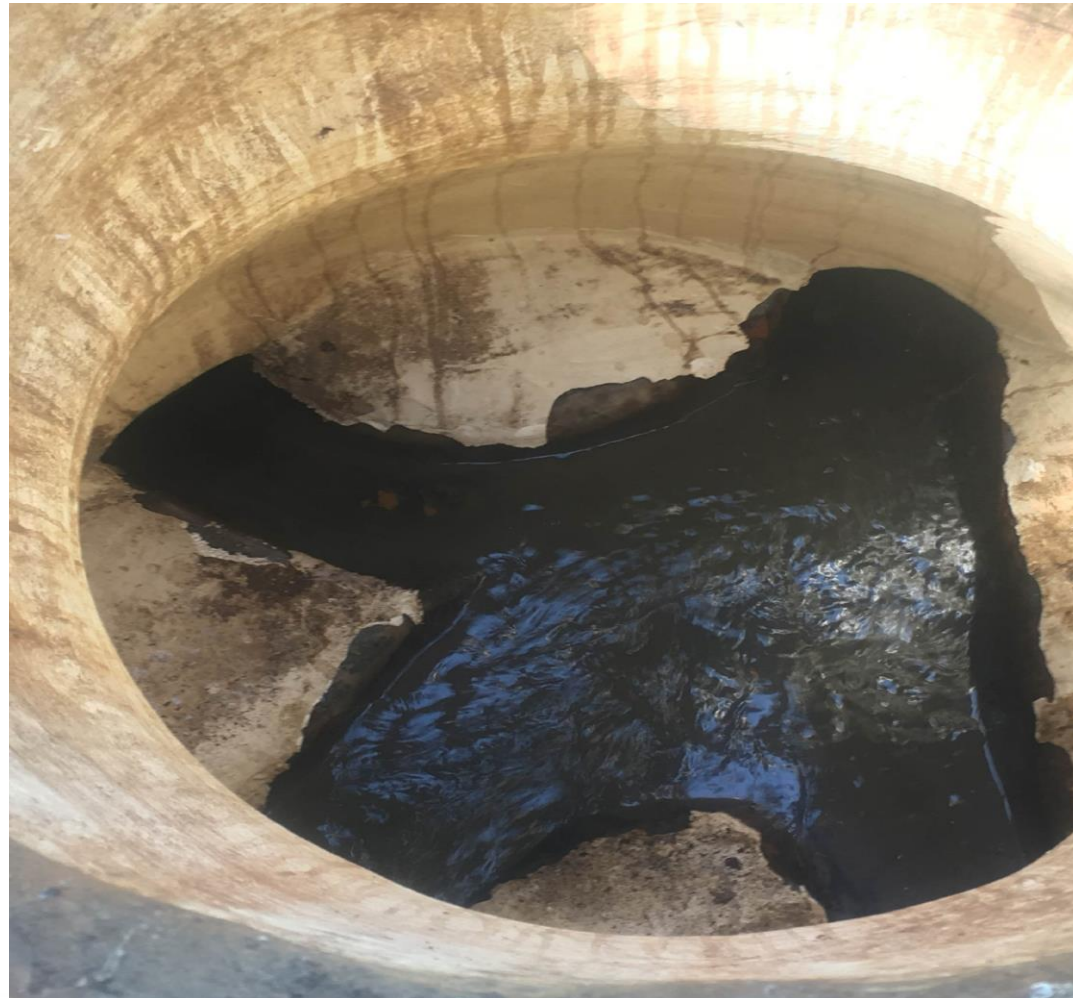
## DISBONDING FAILURE DUE TO POOR SURFACE PREP

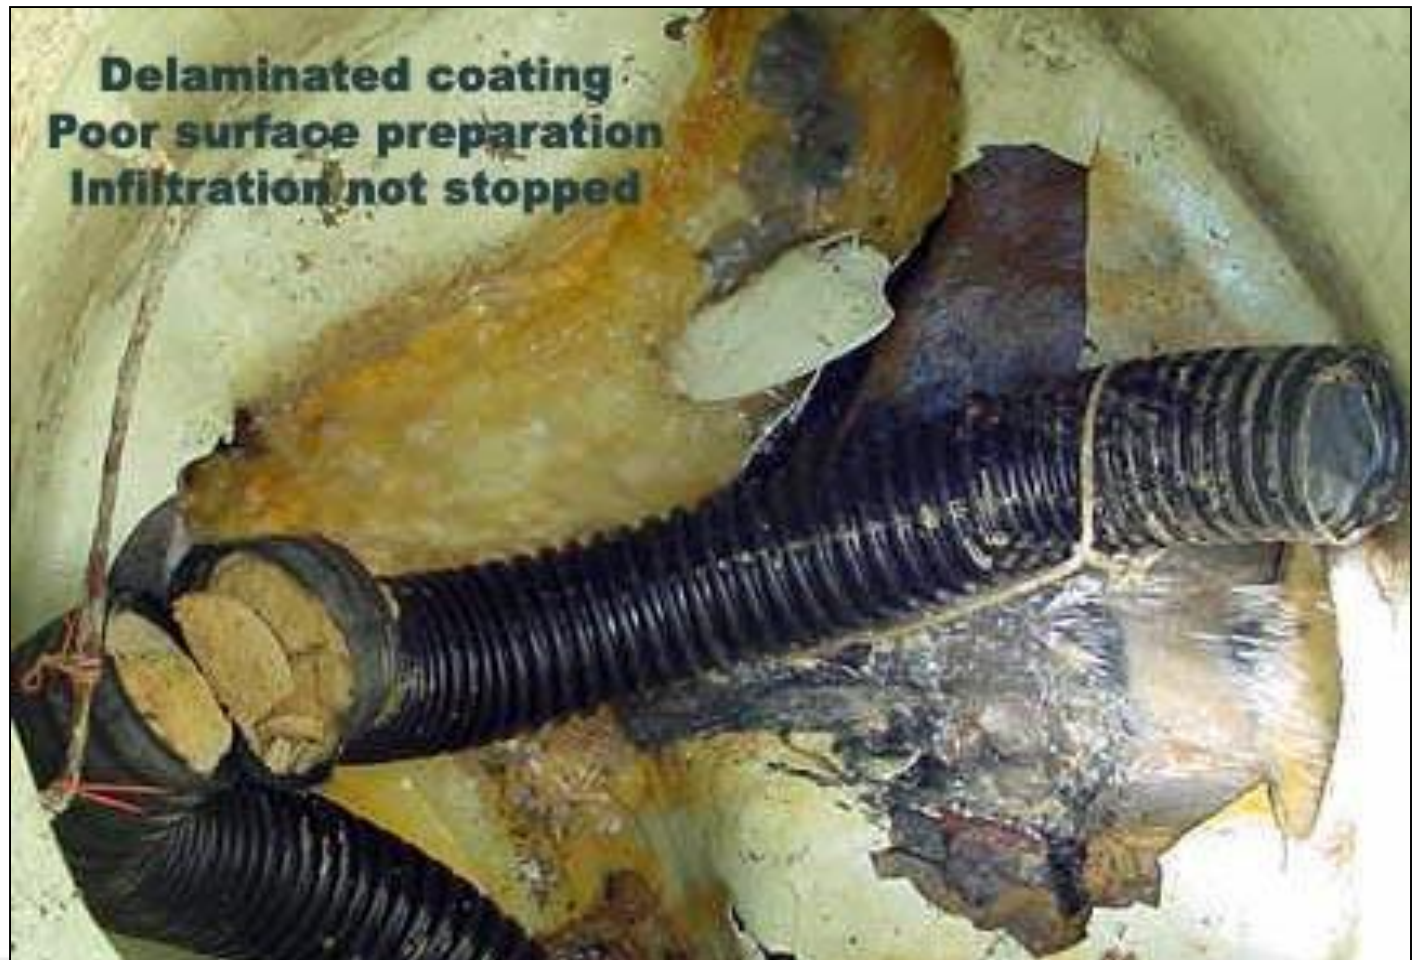
## **DELAMINATED COATING POOR SURFACE PREP-SUBSTRATE**

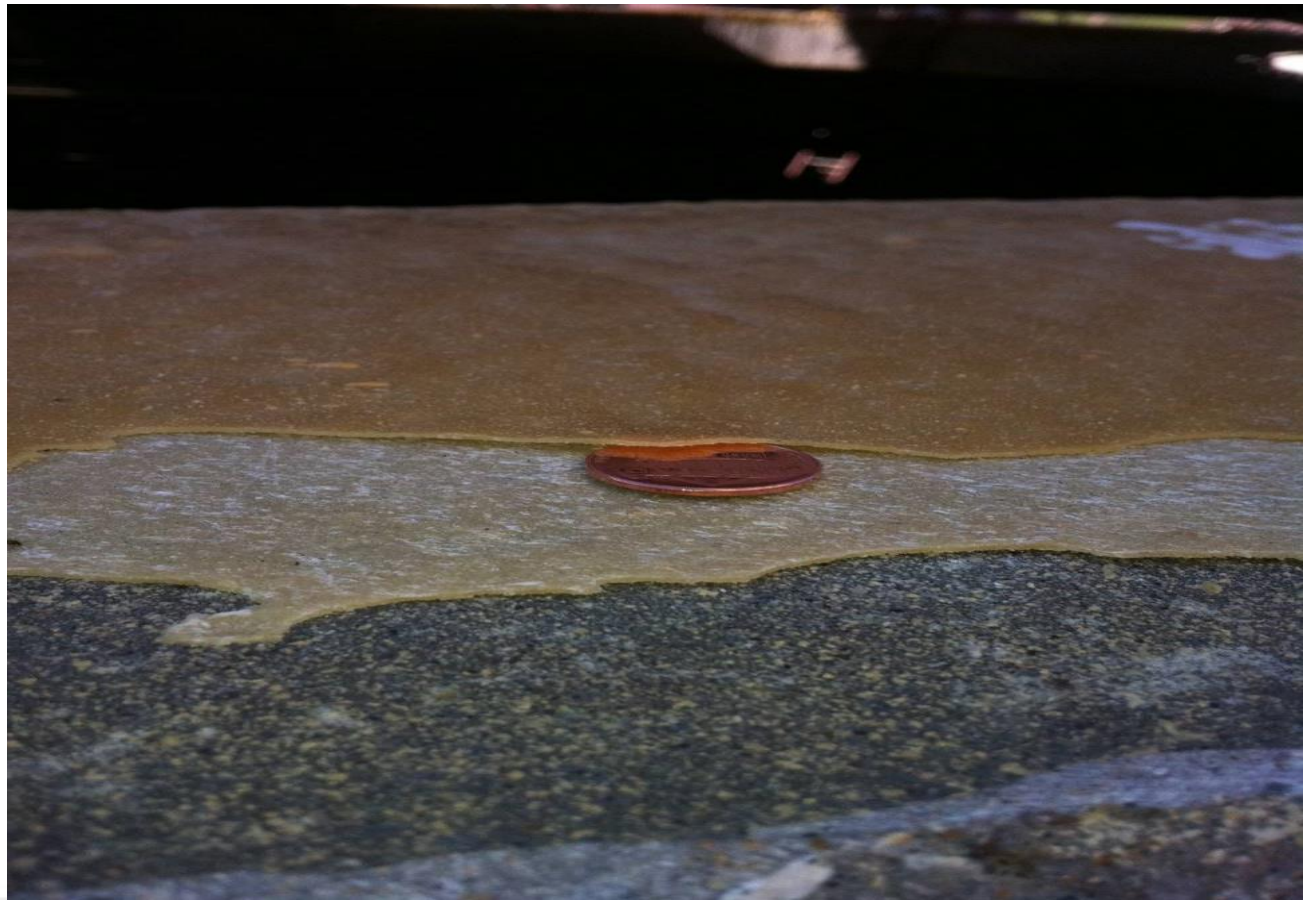
## **INNER COATING DELAMINATION POOR ADHESION- MATERIAL NOT APPLIED PER MANUFACTURER'S RECOMMENDATIONS**

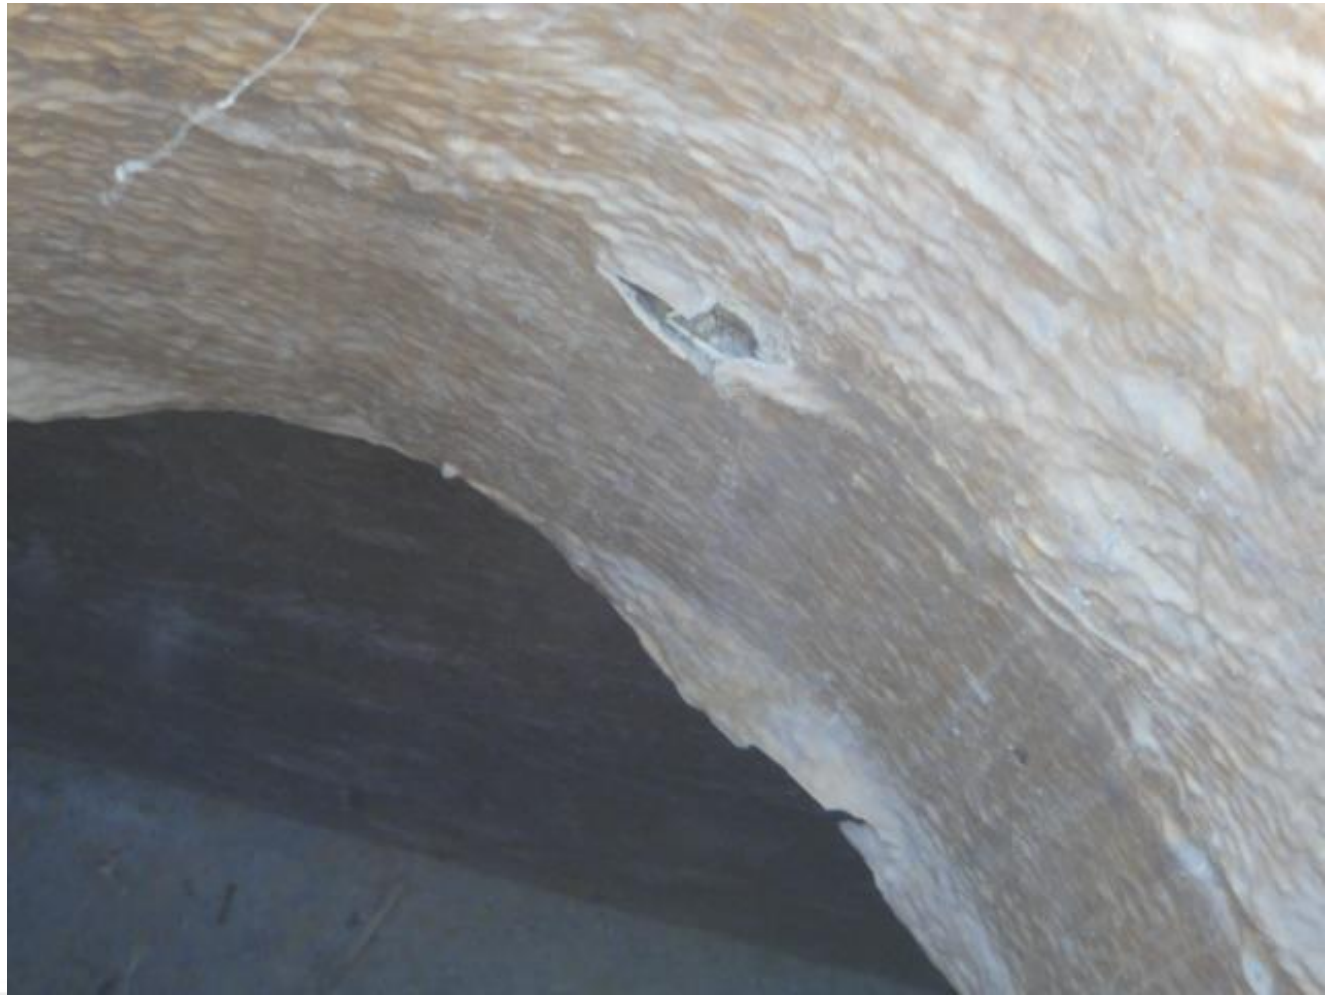
## **LINING DISBONDING-POOR PREP AND HYDROSTATIC LOADING**

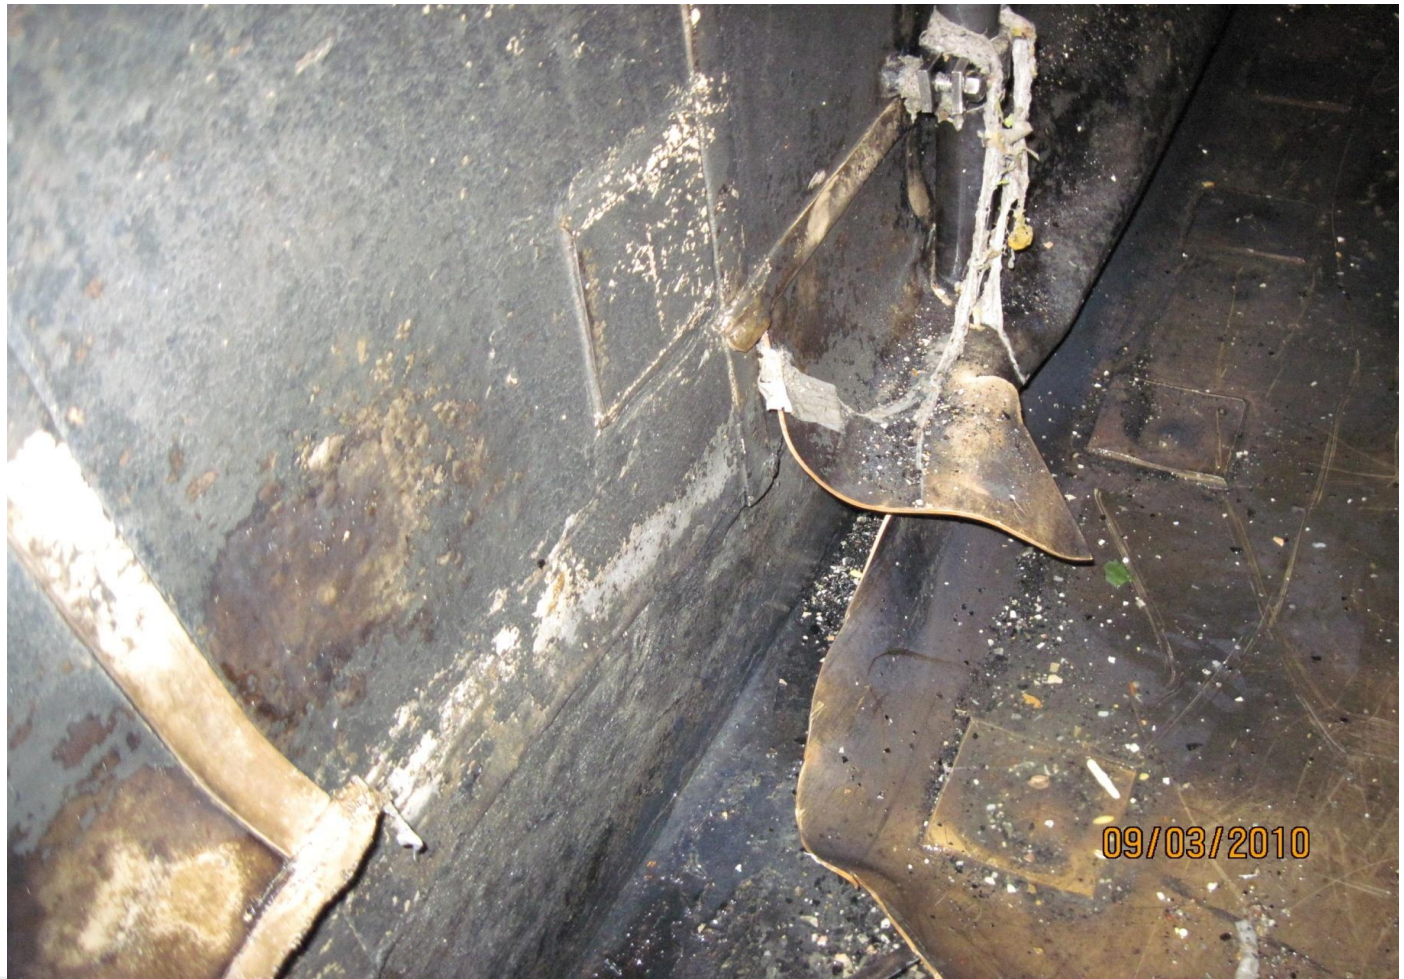
## **SHEET LINING FAILURES POOR WELDING AND PINHOLES**

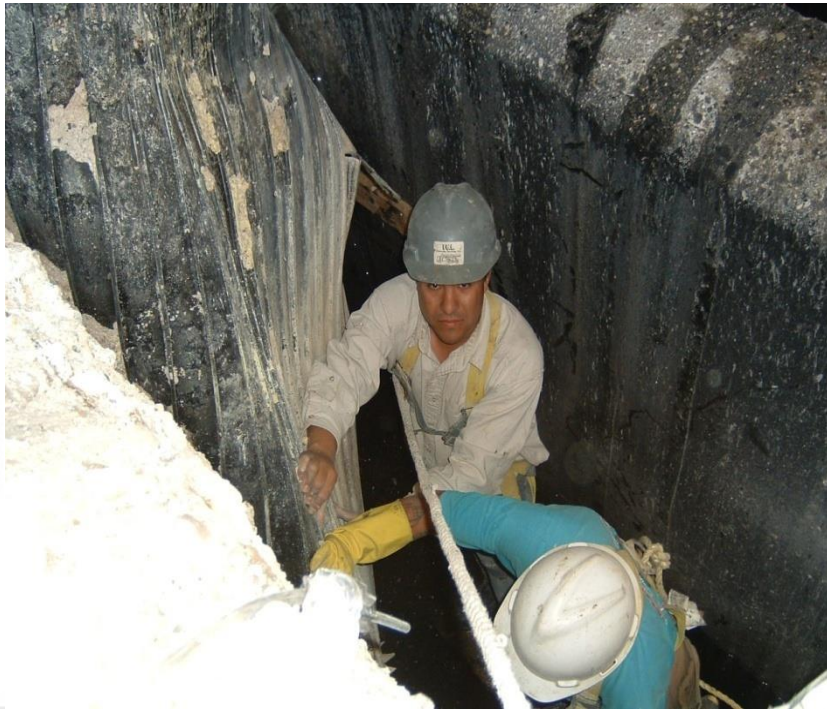
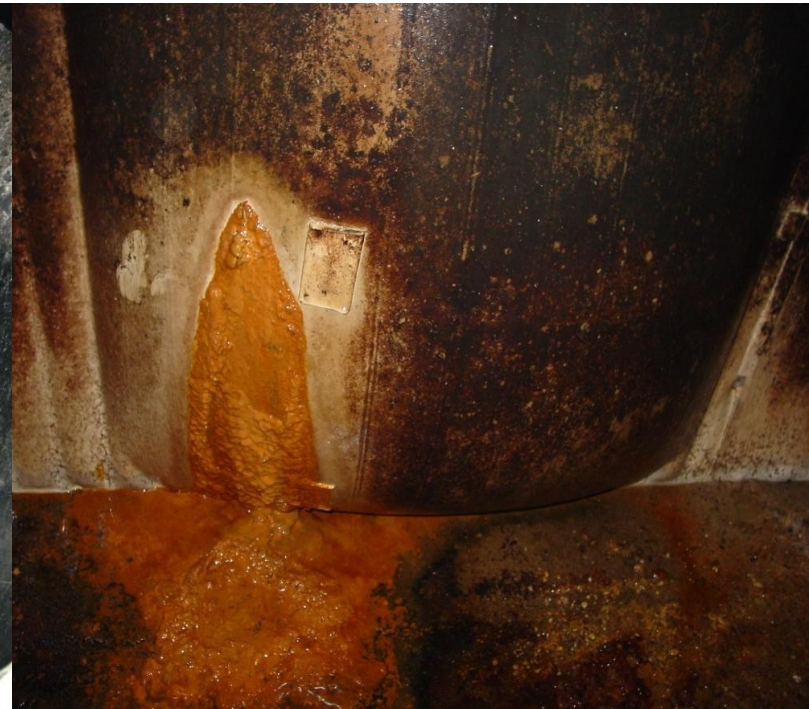
## SUBSTRATE DETERIORATION DUE TO PINHOLES AND POOR WELDS

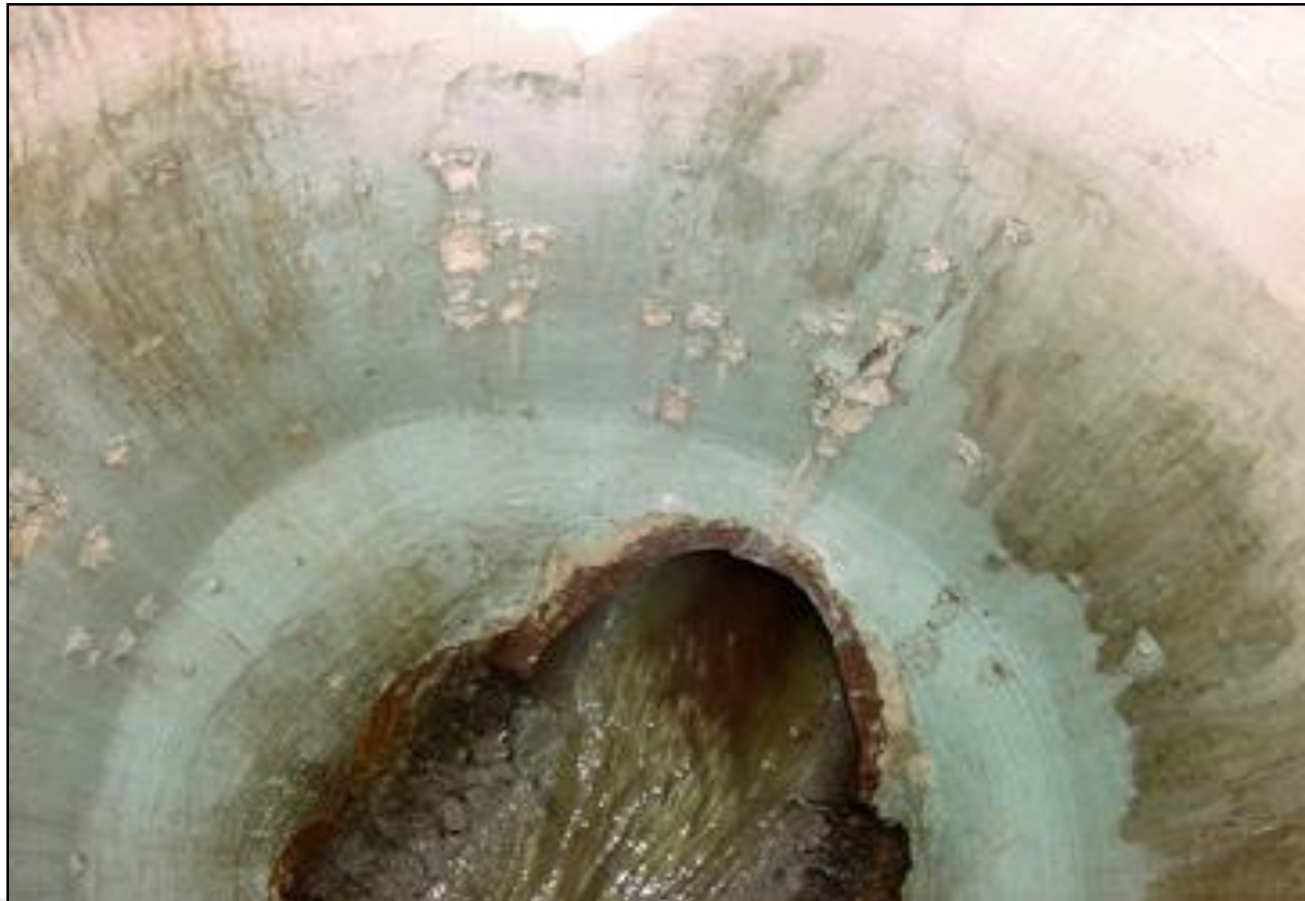
## **PINHOLES AND THINNER COATING THAN RECOMMENDED BY MANUFACTURER**

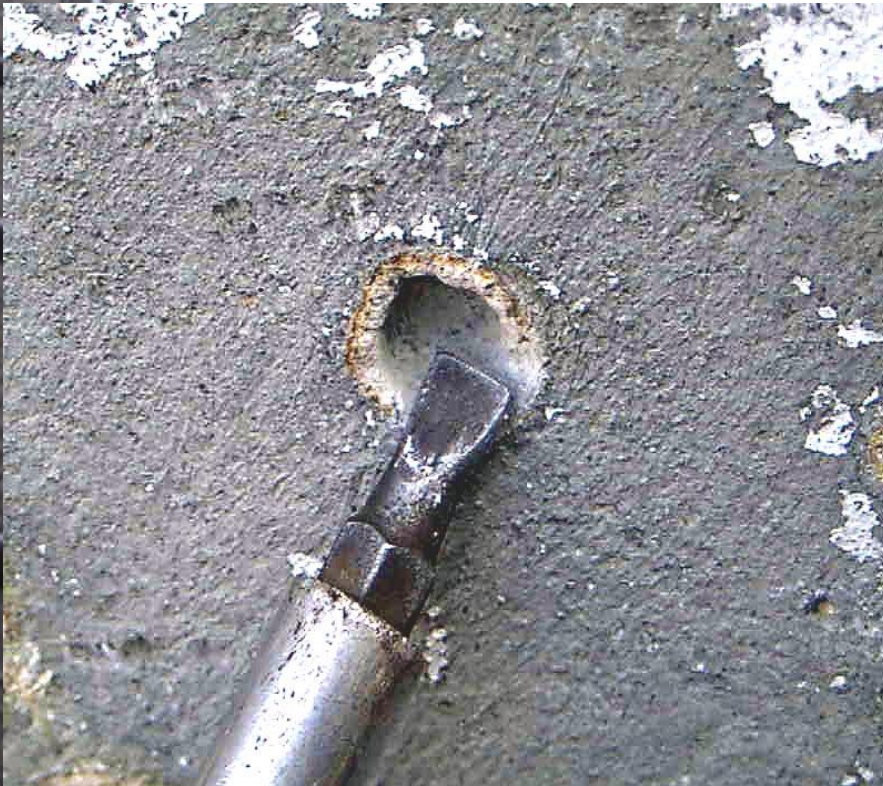
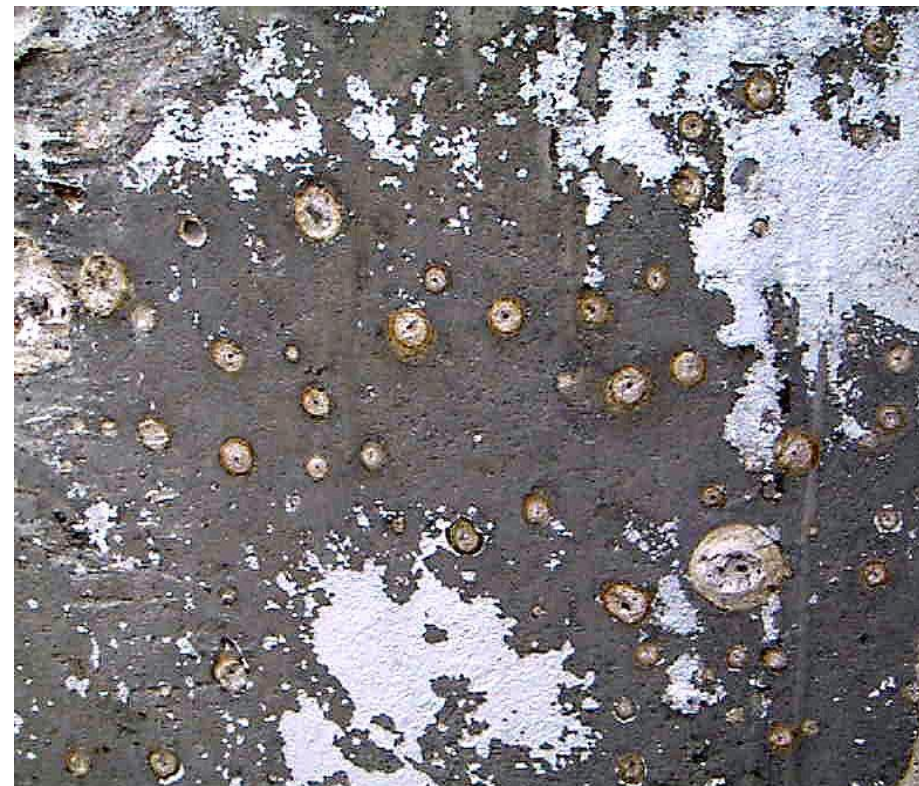
## PINHOLES & THIN COATING
