THE **UNDERGROUND** UTILITIES EVENT

# THE IMPORTANCE OF PROPER INSPECTION

Rocky Capehart

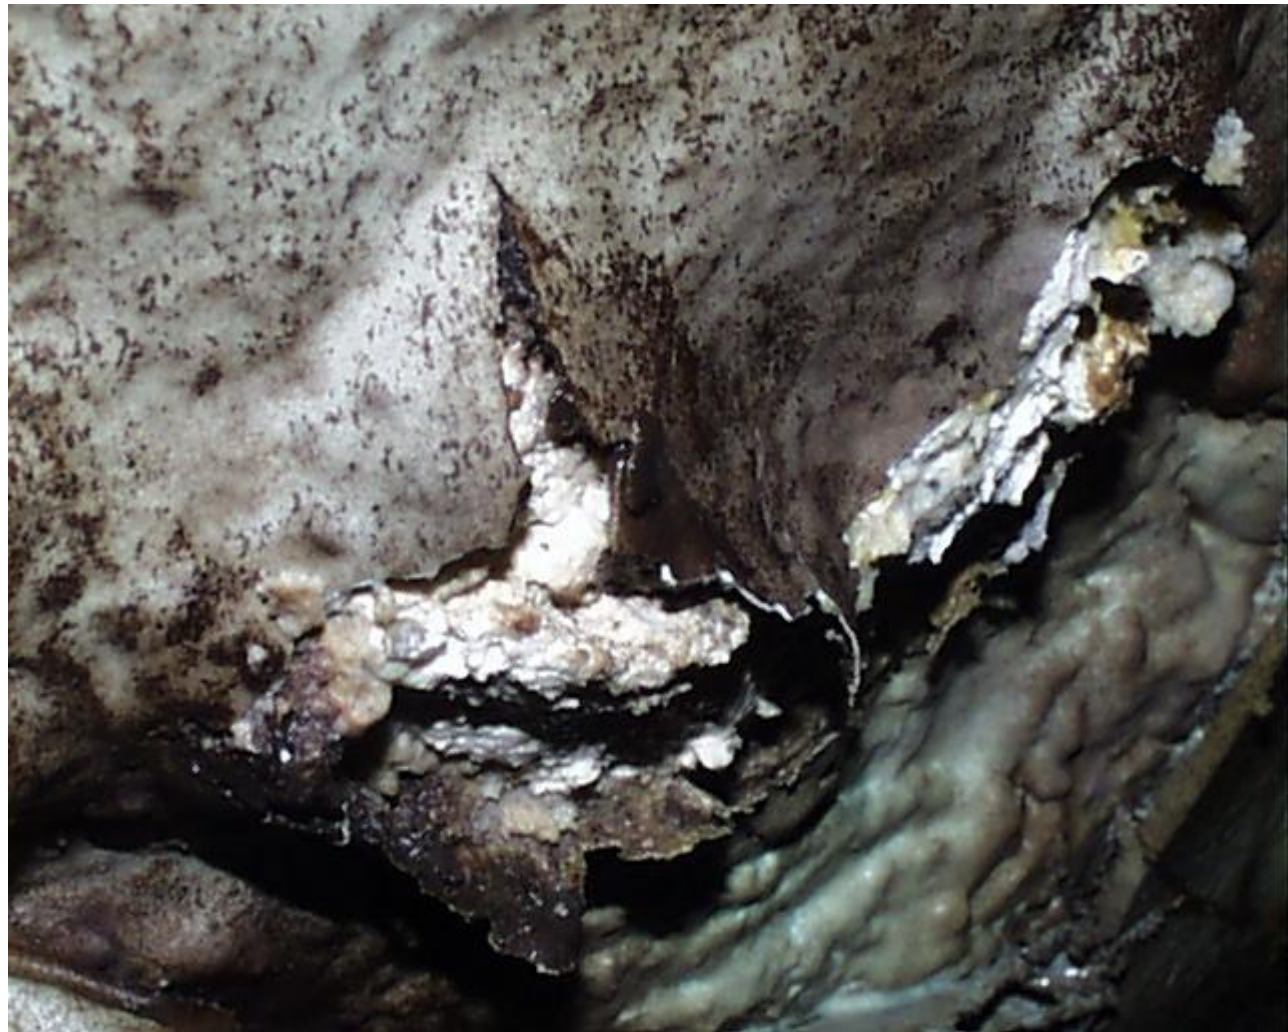
## PINHOLES-AFTER 5 YEARS OF SERVICE

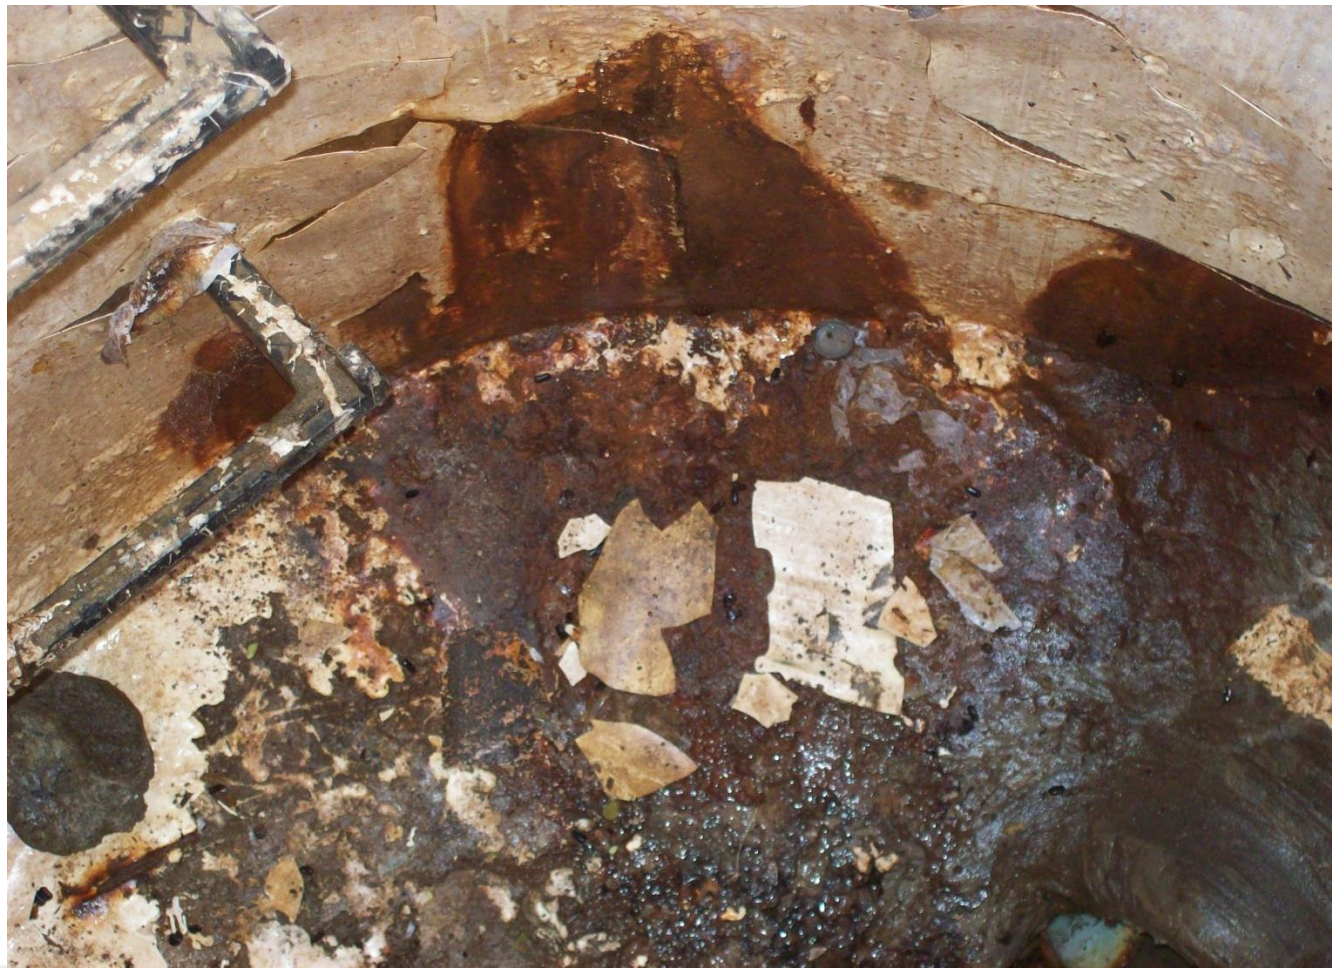
## **BUCKLING FAILURE DUE TO HYDROSTATIC LOADING/POOR PREP**

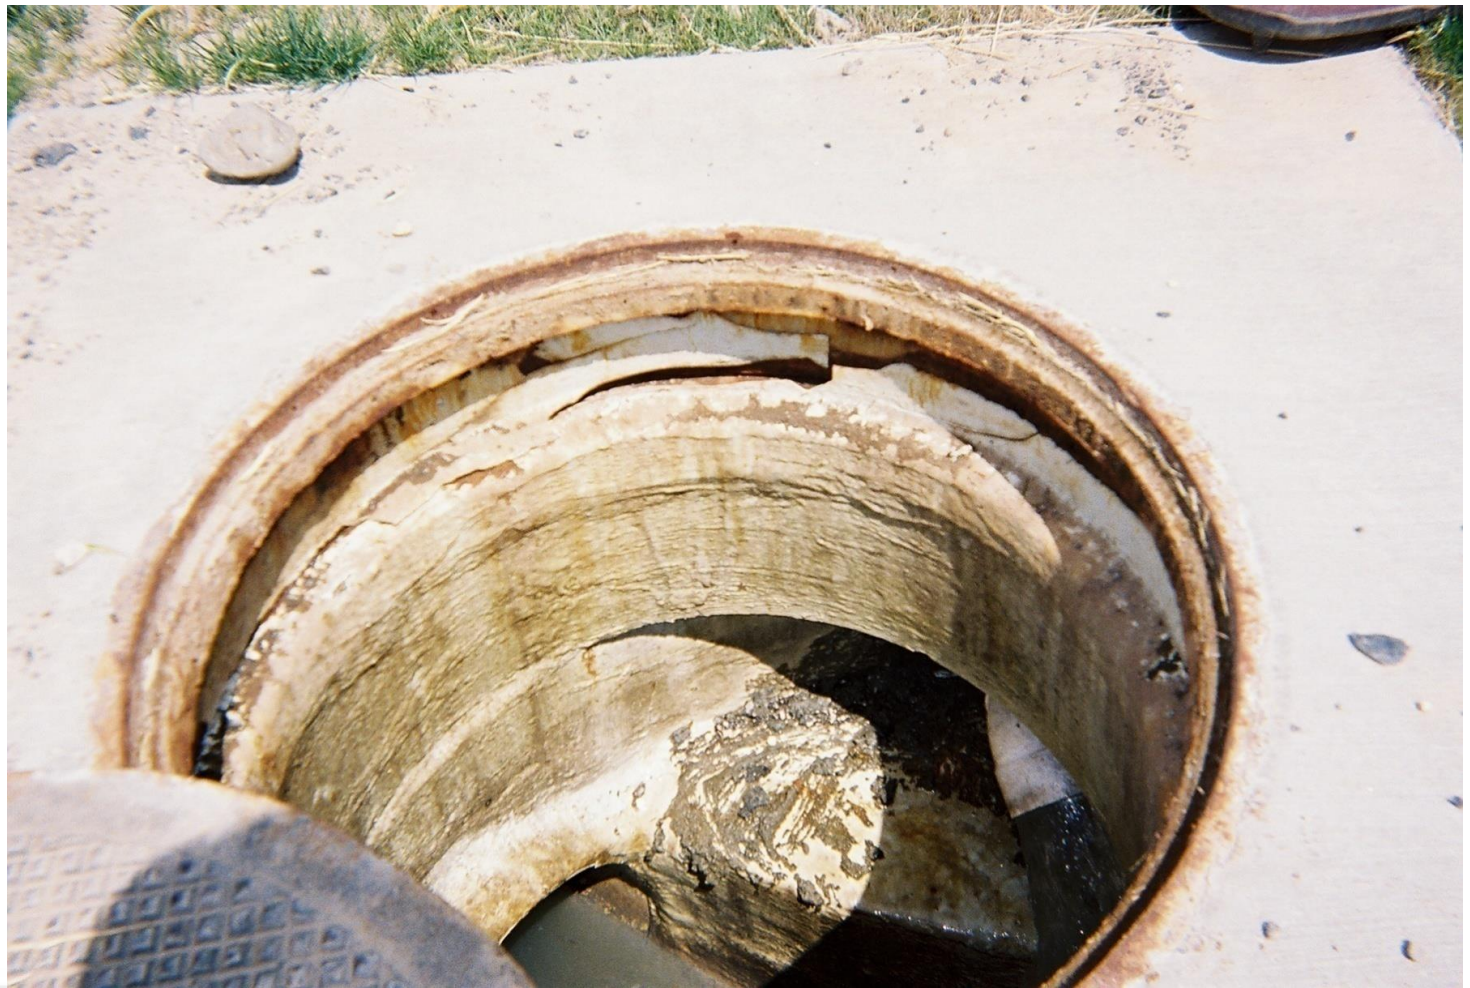
## **FAILURE-POOR PREP COATING THE FRAME IS NOT RECOMMENDED**

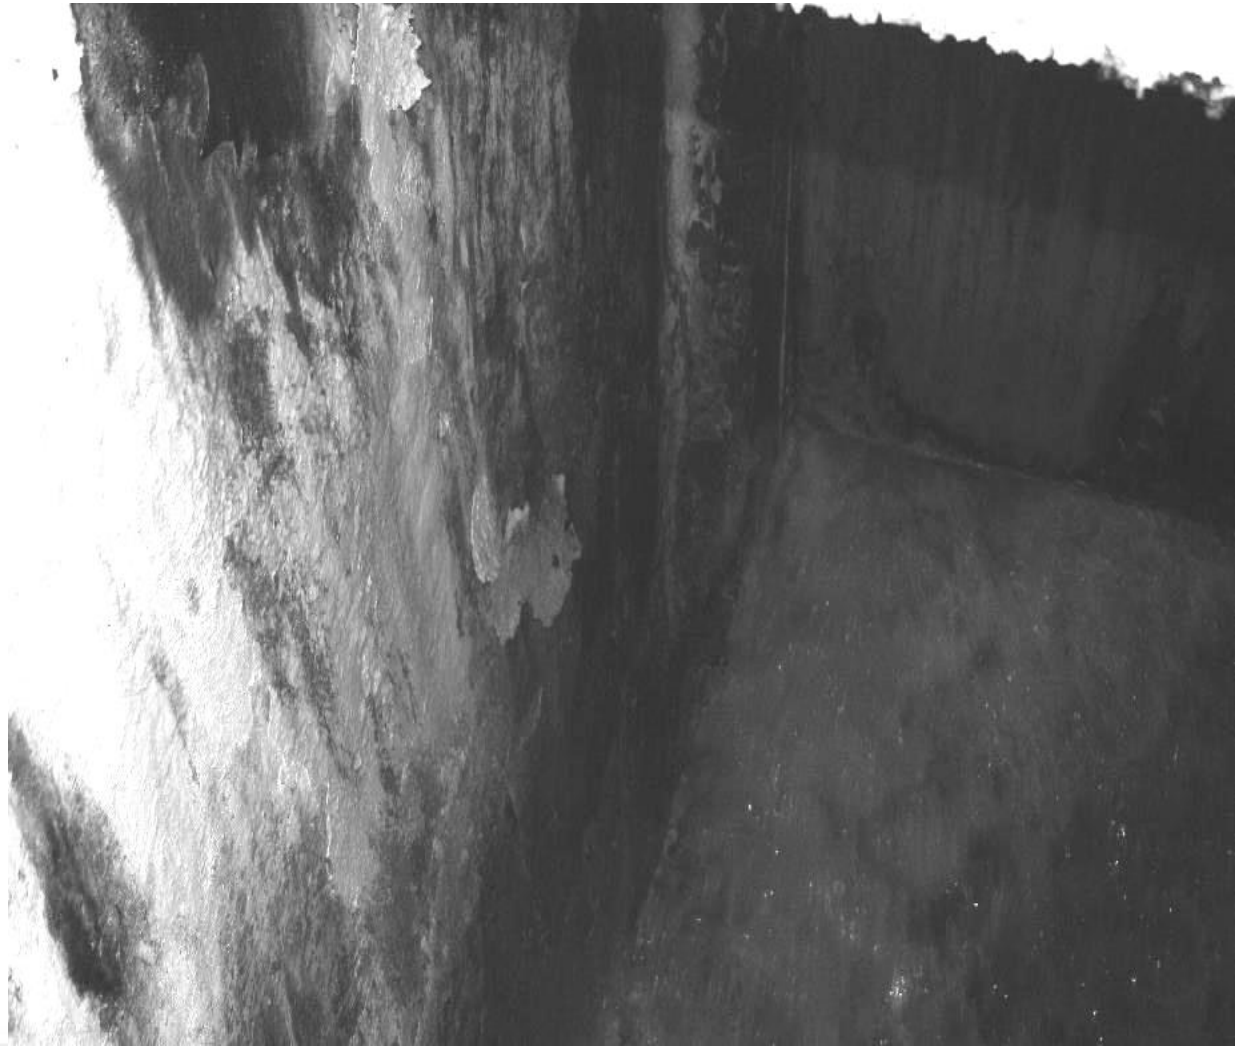
## THINNER THAN SPECIFIED COATING APPLICATION

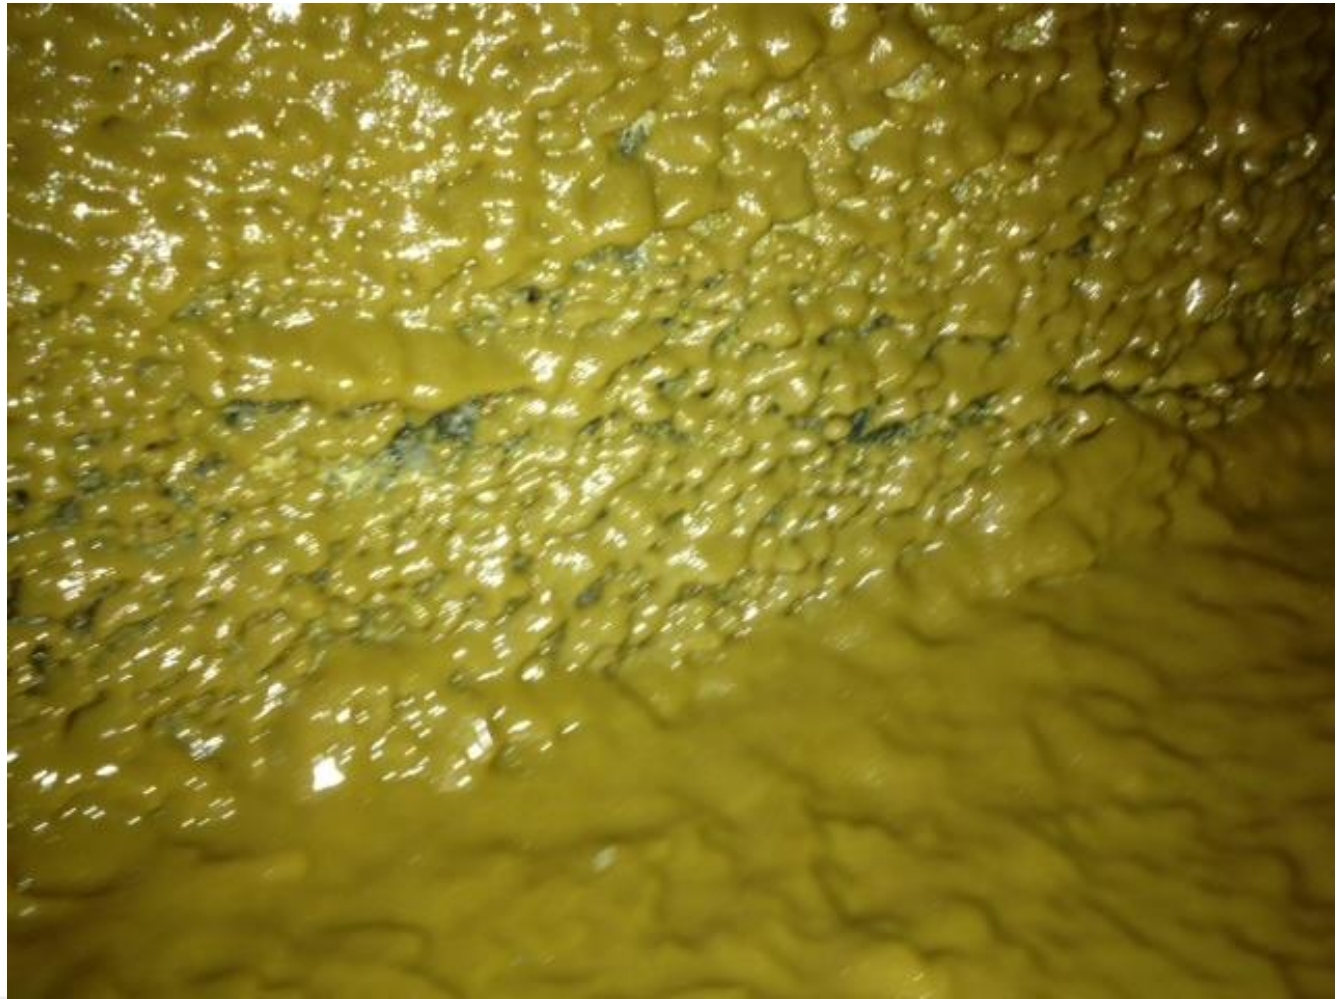
## THINNER THAN SPECIFIED COATING APPLICATION

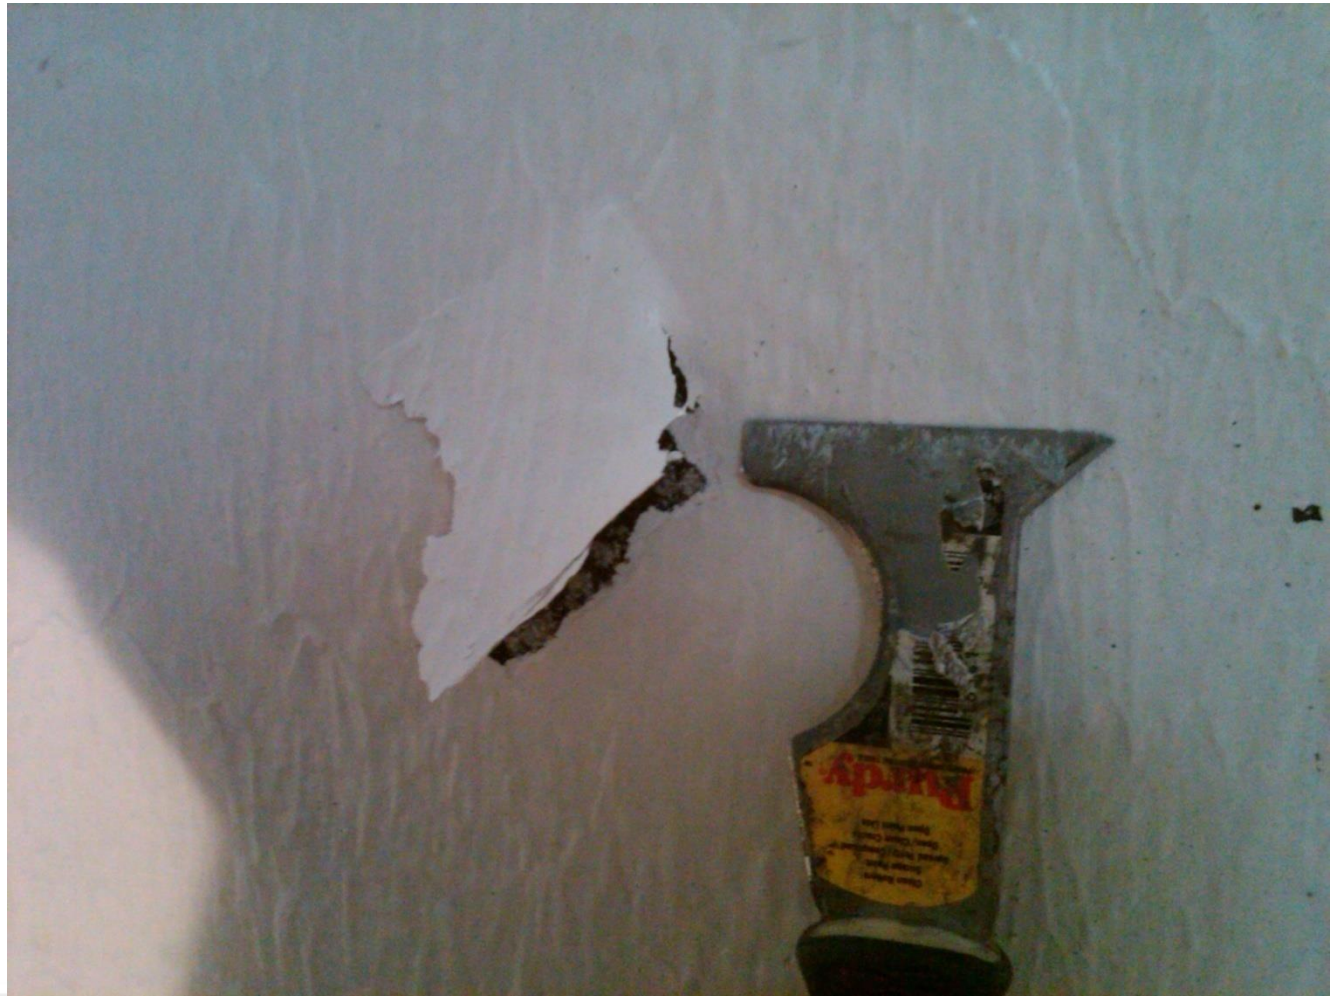
## FAILURE DUE TO IMPROPER APPLICATION PROCEDURE

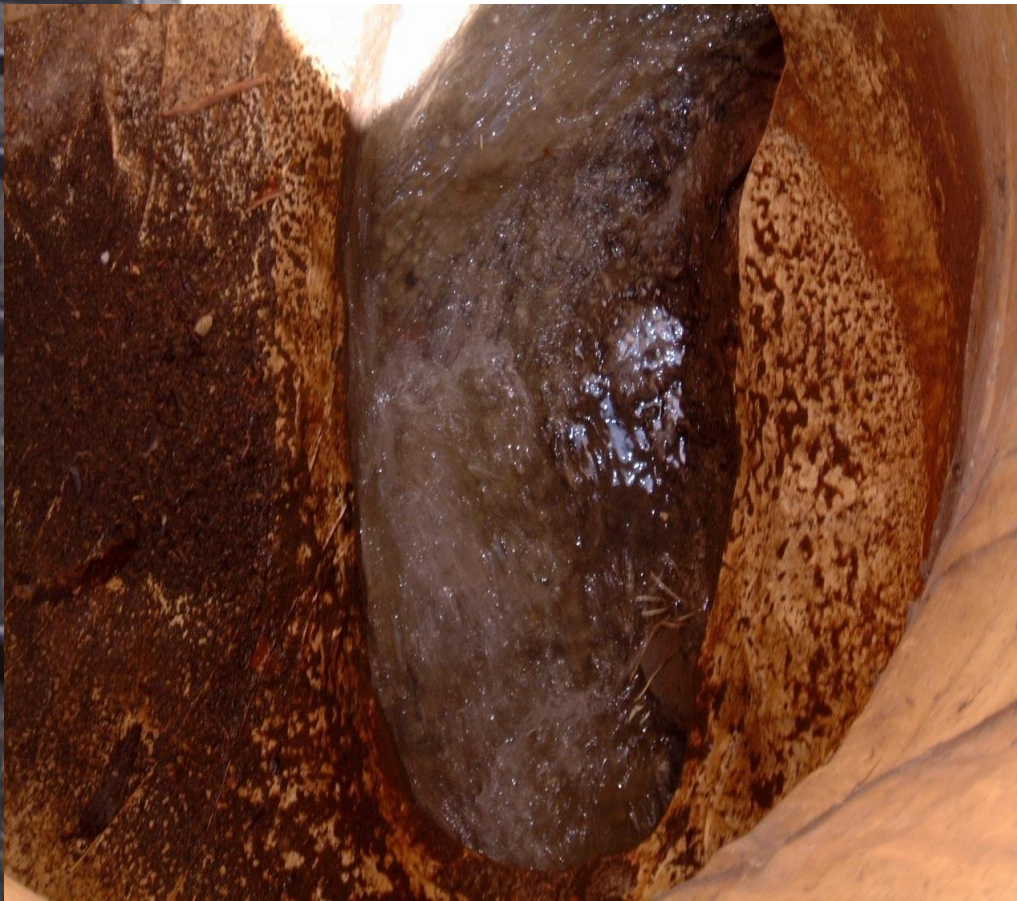
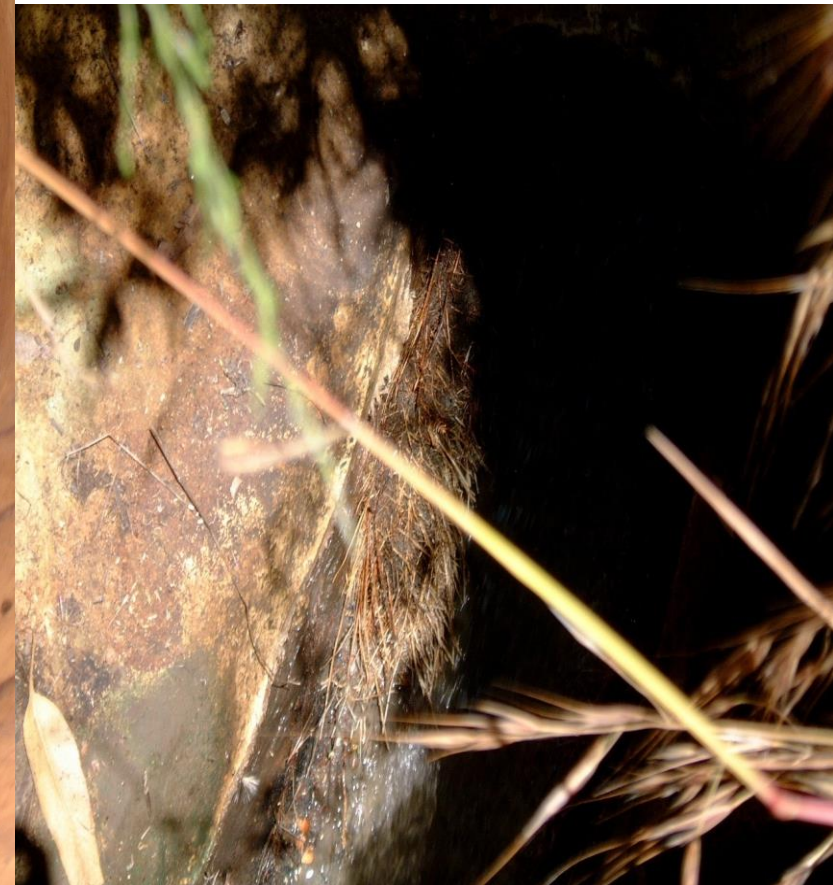
## **MISSING LINING TERMINATION KEYS: NO SEAL AT INTERFACE BETWEEN LINING & SUBSTRATE**

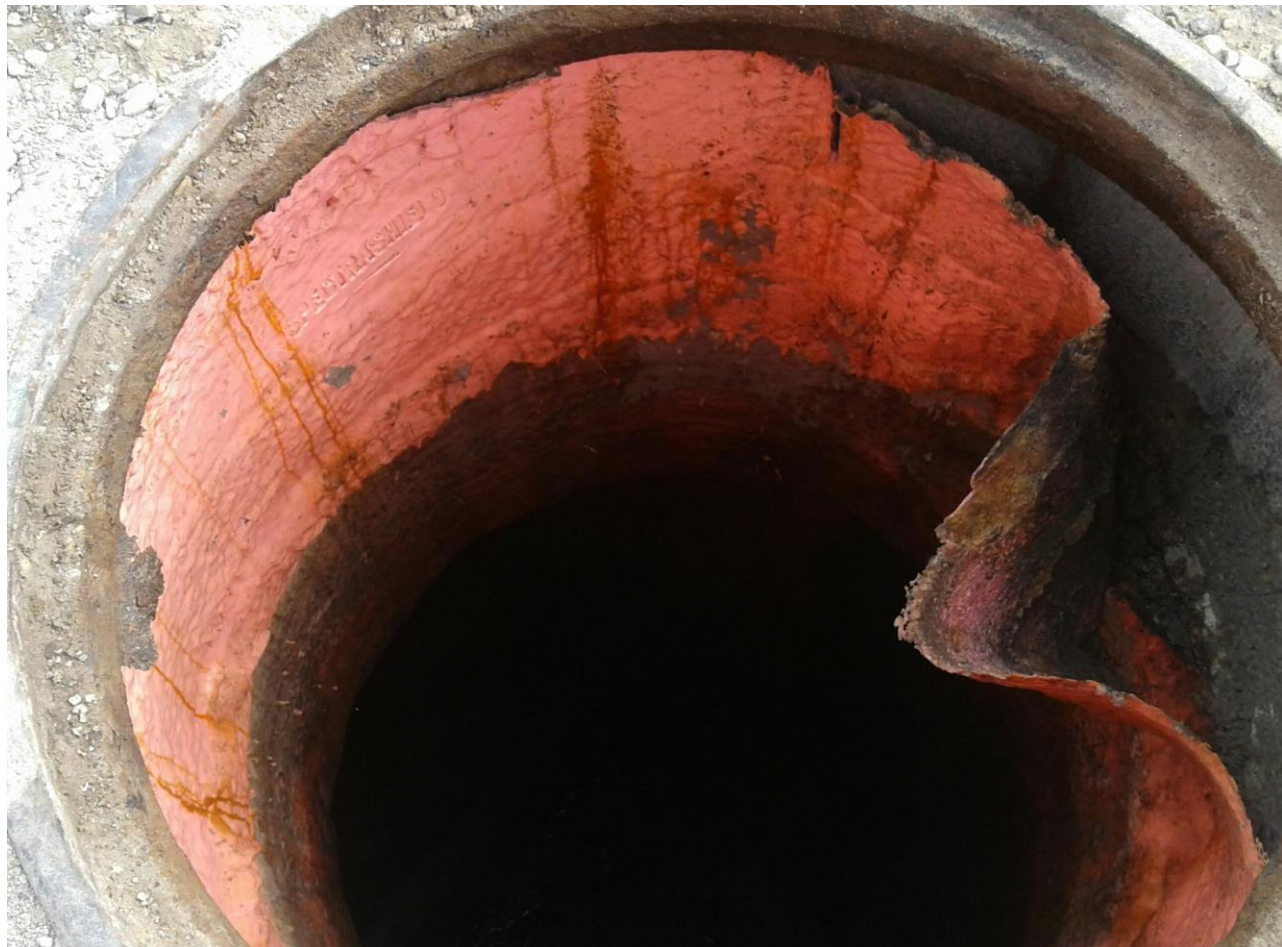
## DISBONDING-IMPROPER APPLICATION
